SERVICE BULLETIN

CHECKING OF THE CRANKSHAFT JOURNAL (POWER TAKE OFF SIDE) FOR ROTAX® ENGINE TYPE 912 AND 914 (SERIES)

MANDATORY

SB-912-059**SB-914-042**

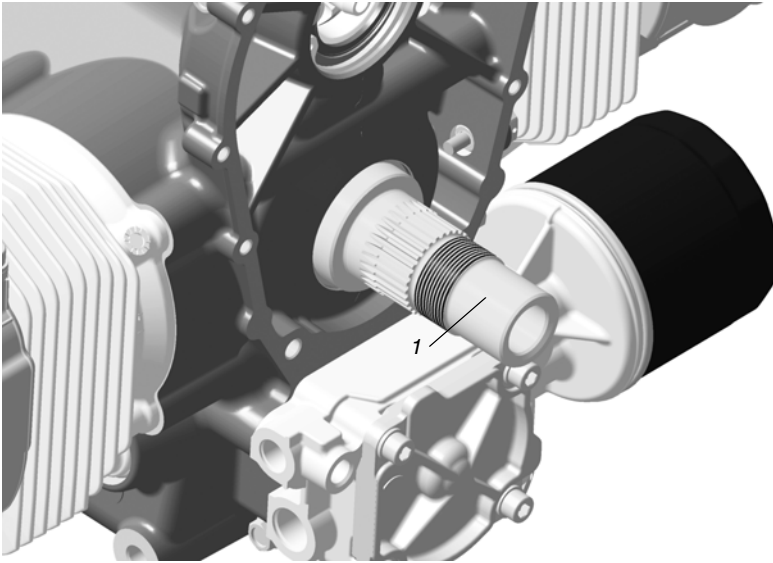
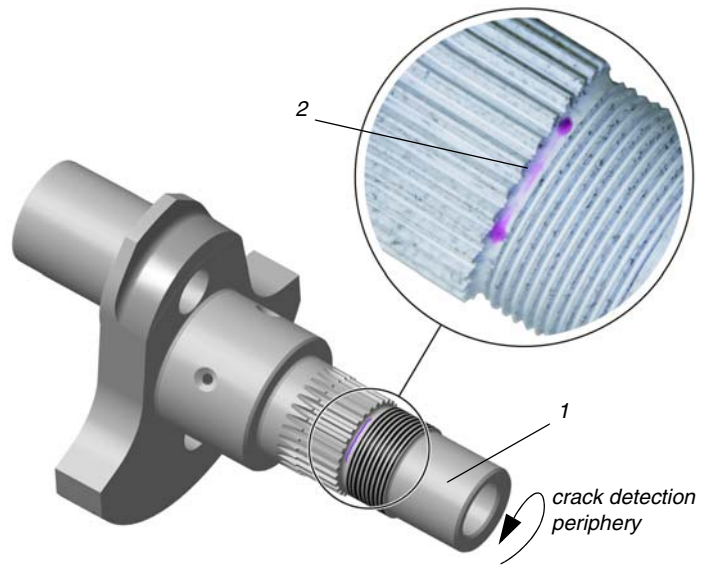
Fig. 1
crankshaft journal

Due to a deviation in the manufacturing process some crankshafts may have a crack formation occur on the power take off side. These cracks can cause a breakage of the crankshaft support bearing and may lead to engine stoppage.

- Detailed crack detection in the area (2) of the thread runout using penetration test. Perform this test in accordance to the requirements of the applicable aviation authority in your region for non destructive testing (NDT) and according to DIN EN 571 or equivalent.

- 1 crankshaft
- 2 detailed crack detection

- ◆ NOTE: Protect the crankcase against contamination by the test material.
 - CAUTION: In case of crack or doubt contact your aircraft manufacturer and your nearest authorized ROTAX aircraft engine distributor. The engine must not be taken into operation until the cause has been identified and eliminated.

7. If no cracks can be found, then the reassembly has to be conducted in accordance with following steps:
 - Lock the crankshaft in accordance with the relevant Maintenance Manual (Line).
