SERVICE INSTRUCTION

FRICTION TORQUE CHECK OF PROPELLER GEAR WITH OVERLOAD CLUTCH ON ROTAX_® ENGINE TYPE 912 AND 914 (SERIES) SI-06-1997 R1

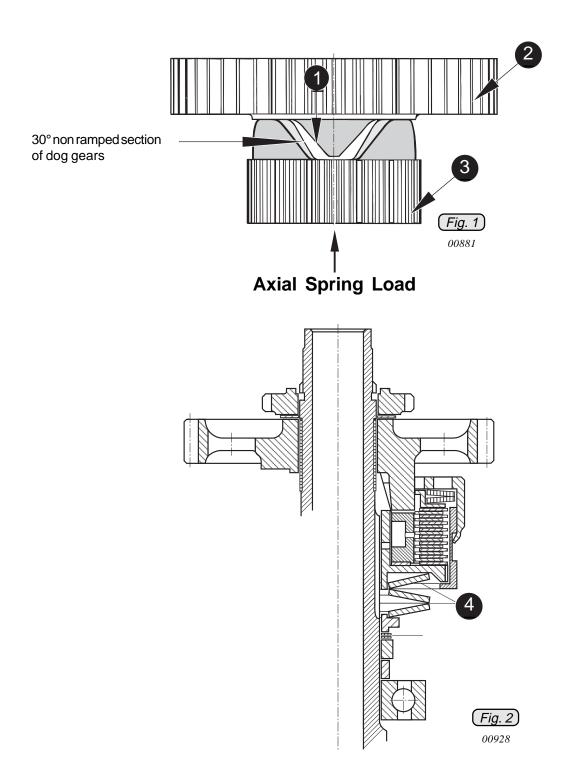
The torsion shock absorber consists of a dog hub (3) with helical dogs (1) in engagement with the propeller drive dog gear (2).

The helical dogs on the hub are kept in contact with the corresponding dogs on the propeller drive gear by over 11 00 pounds of axial spring load from a number of disk springs (4). Engine power is transmitted to the propeller drive dog gear by the gear mounted on the crankshaft. The propeller drive dog gear then transmits engine power to the propeller shaft via helical dogs and the splined dog hub (1).
