SERVICE INSTRUCTION

OIL LEAKAGES IN THE AREA OF THE CYLINDER BARREL FOR ROTAX[®] MOTOR TYPE 912 i, 912 AND 914 (SERIES)

SI-912 i-006 R1

SI-912-019 R3

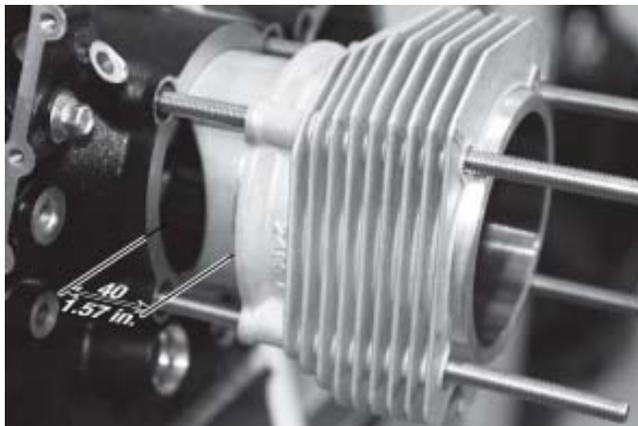
fig. 1

3. Remove O-ring 87x2 (1).
4. Remove the 4 threaded studs (2, 4). Do not mix them up. Refer to Fig. 7 for correct placement of studs. The maximum screw-in length has to be considered!

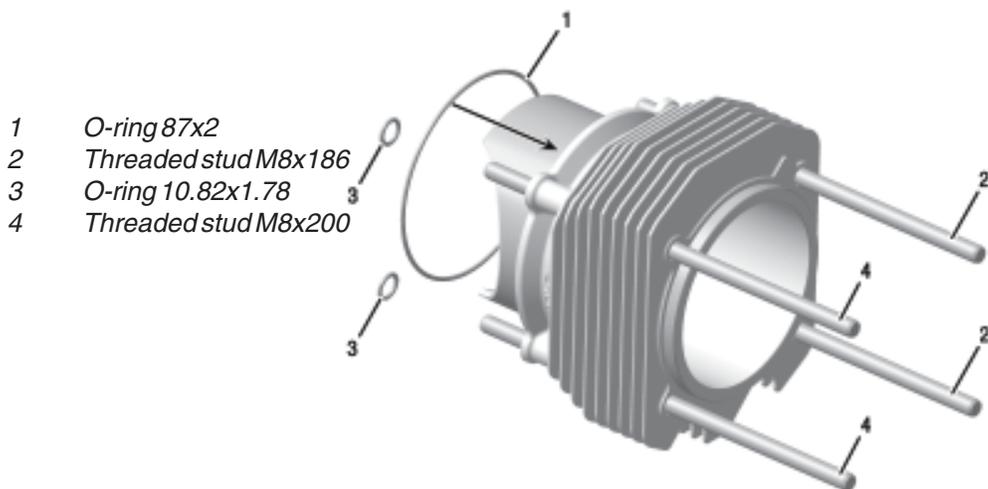
fig. 2

- 1 O-ring 87x2
- 2 Threaded stud M8x186
- 3 O-ring 10.82x1.78
- 4 Threaded stud M8x200

- **CAUTION:** Piston and piston rings may get damaged. Support piston by hand!
5. Install new cylinder base O-ring 87x2 (1) part no. 250510. Stretch the O-ring over the cylinder and position it.
 6. Install 2 threaded studs M8x186 (2) at the threaded sleeves M8. Tightening torque 3 Nm (27 in.lb).
 7. Lubricate O-ring 10.82x1.78 (3) part no. 431570 and insert into crankcase.

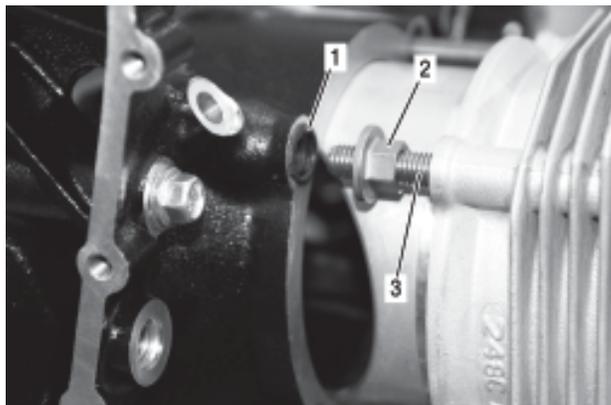
fig. 3

- 1 O-ring 10.82x1.78
- 2 Collar nut M8
- 3 Threaded stud M8x200

8. Seating o-ring (3): Insert threaded stud M8x200 (3) into cylinder and screw on the collar nut M8 (2) part no. 942301 approx. 15 mm (0.59 in.). Make sure cap of capnut points in the direction of crankcase.

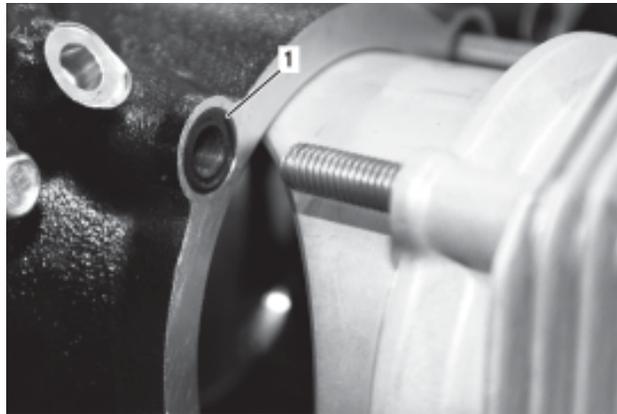
09799
fig. 5

1 O-Ring 10.82x1.78

11. Loosen cap nut M8 and remove it.
- ◆ NOTE: Check if O-ring is in correct position (fully seated)!

12. Tighten threaded stud M8x200. Tightening torque 3 Nm (27 in.lb).

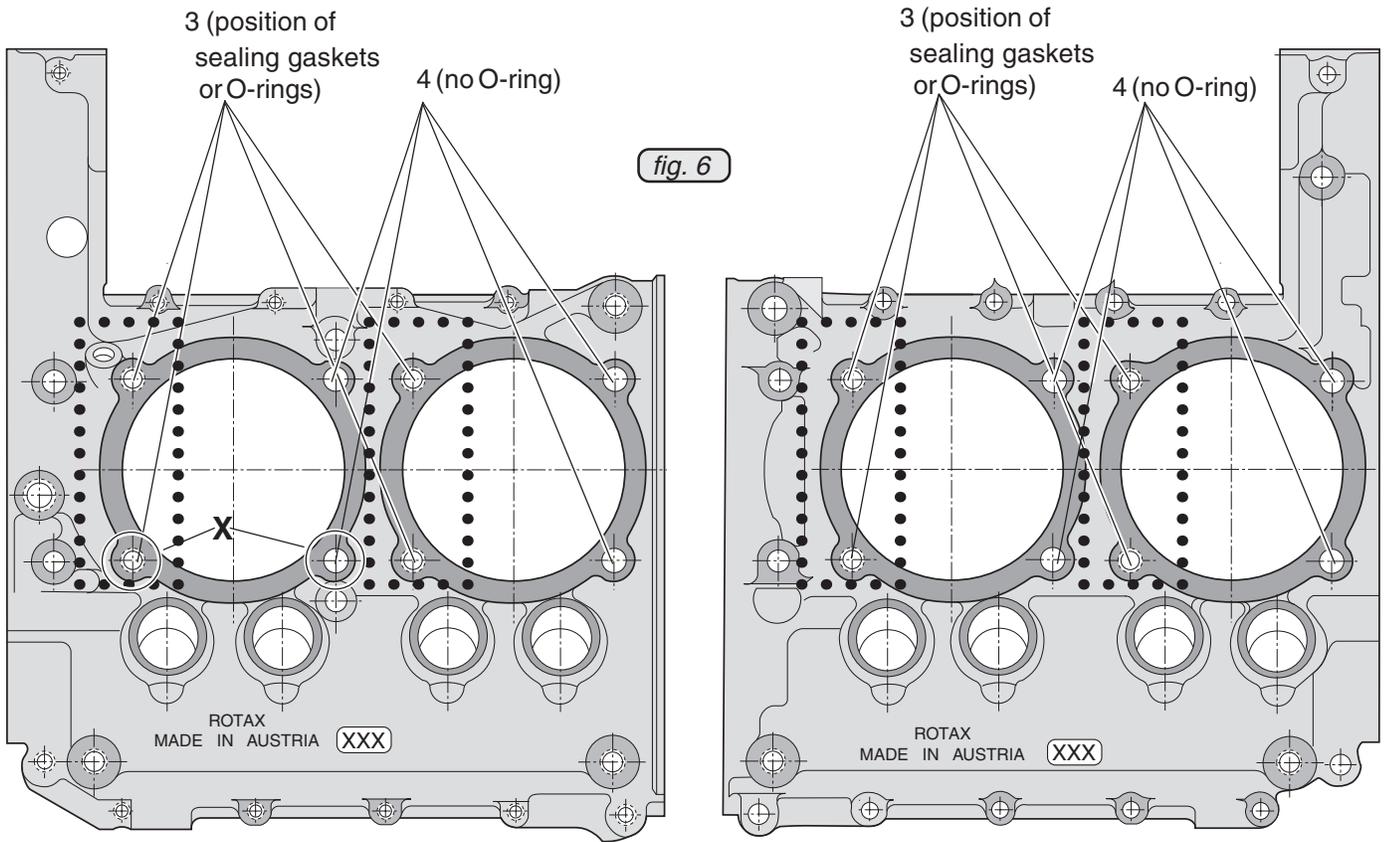
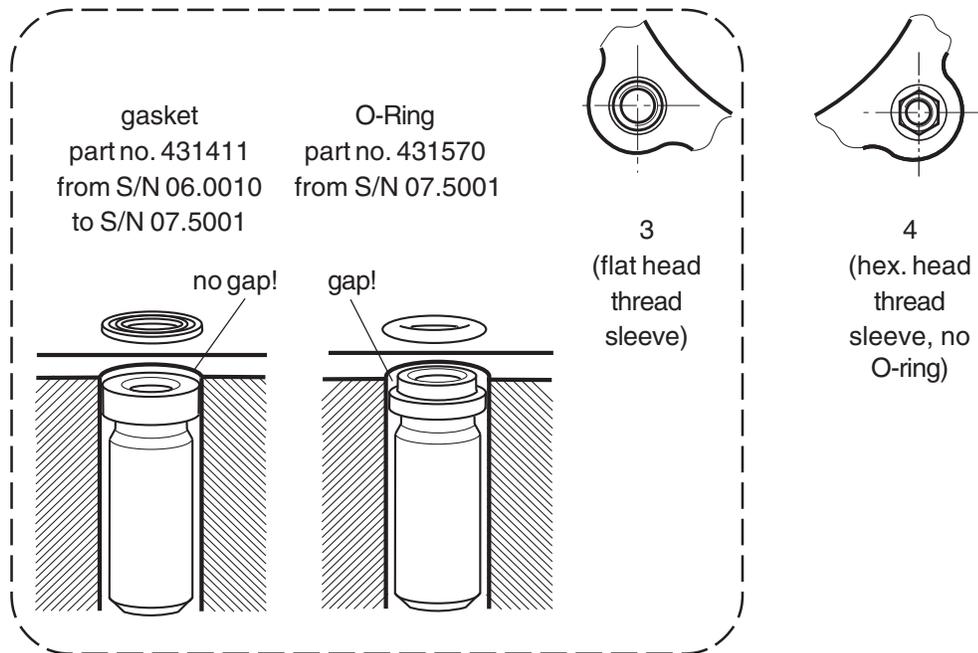
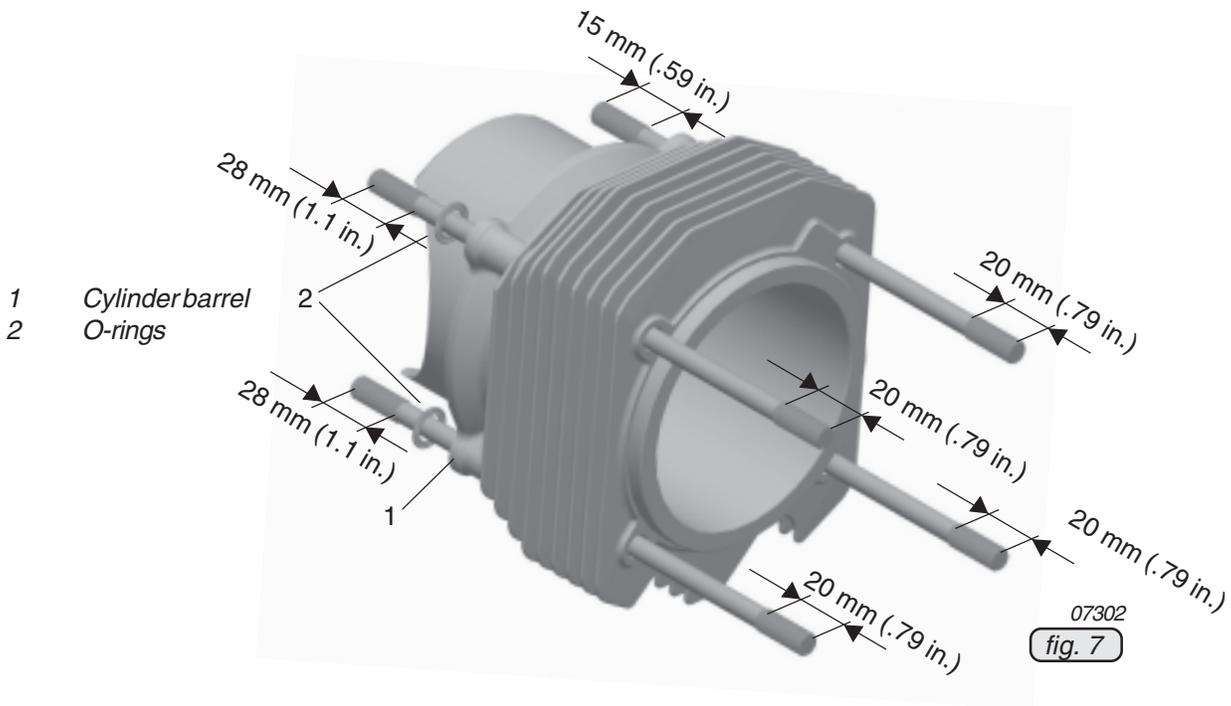
- in the area of the cylinder barrel (1), at O-ring location (2)
- if you notice oil leaks in this area then the following work has to be performed.

07573
 •••• position of sealing gaskets or O-rings on the left hand studs
