SERVICE LETTER IDENTIFYING ABNORMAL VIBRATIONS ON AIRCRAFTS

EQUIPPED WITH ROTAX ENGINE TYPE 912 S/ULS/ULSFR SL-912-010

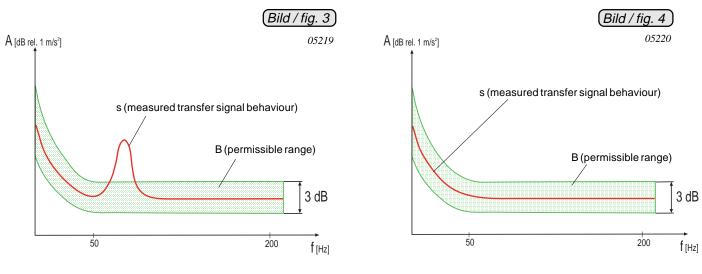
To avoid increased vibrations as described earlier, resonance should not occur on the airframe or on any other component that serves as a connecting element between airframe and engine. This means that no transfer signal overtravel beyond the 3 decibel (dB) acceleration range must exist within the overall range 50 to 200 Hz.

ideal transfer signal behaviour

measurement with distinct resonance

To find and remedy the cause of increased vibration perform vibration analyses and modify the mechanical transmission elements of the engine suspension system until the transfer signal is within the permissible range.

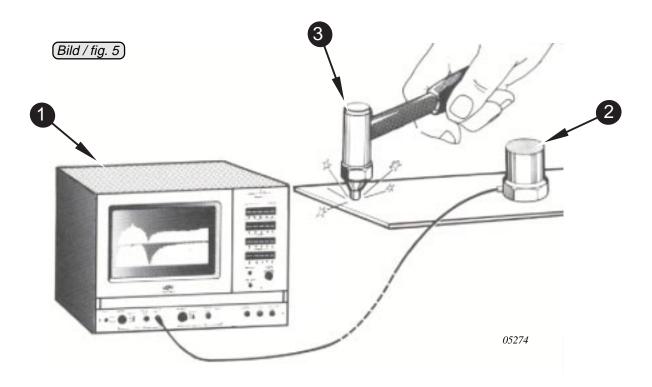
The impact hammer (3) creates a release of excitation energy that spreads evenly across the system's overall frequency range. A frequency analyzer (1) receives the reply signal from the acceleration pick-up transducer (2) (preferably a three-axis type sensor), and represents the transfer of energy function graphically.

♦ NOTE: Schematic representation to excite a system and determine transfer function.
