SERVICE BULLETIN

CHECKING ECCENTERS AND FUEL PUMP PLUNGERS

FOR ROTAX® ENGINE TYPE 912 (SERIES)

SB-912-049UL

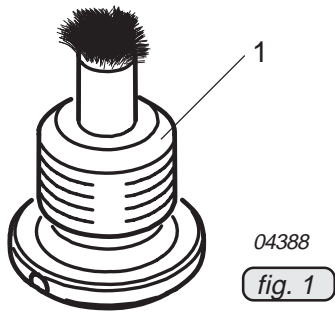
Steel chips in small quantities as shown in Fig. 1 are acceptable as long as the layer thickness is less than 3 mm. If the findings are unclear, the oil circuit must be flushed and a new oil filter installed.

If a quantity of chips (less than 3 mm) is found on the magnetic plug (1) and wear is found on the plunger of the fuel pump, then the eccentric and the fuel pump must be replaced.

The propeller gearbox with drive gear must be sent to the authorized distributor or their service center for repair.

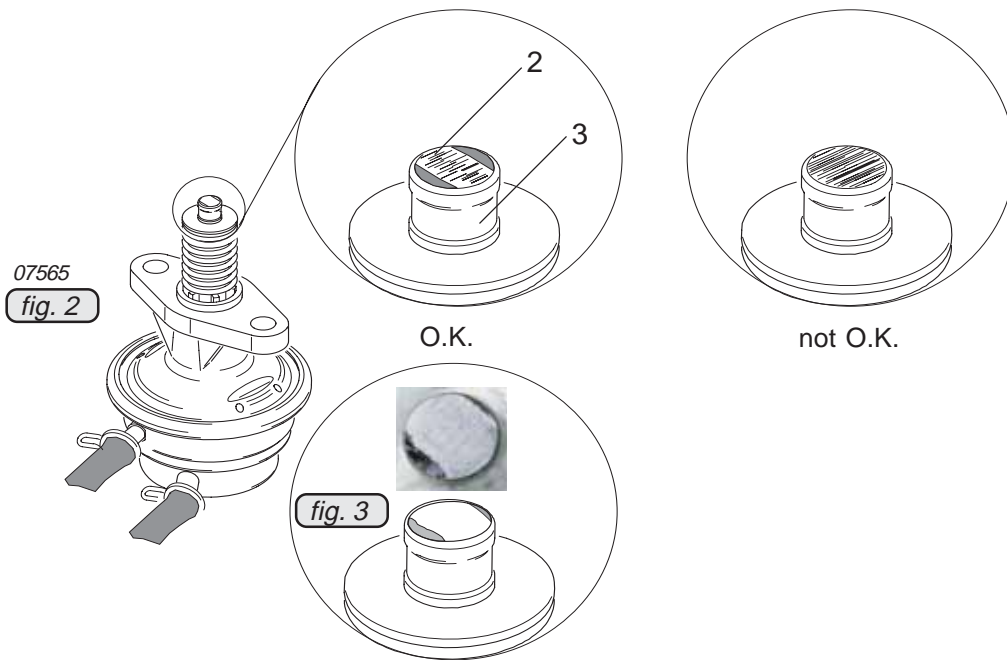
- Remove fuel pump
- Detailed check of the surface (2) of the fuel pump plunger (3). The contact surface with the eccentric must have no corrosion. Wear traces that appear slight are permissible. See Fig. 3. The width of the contact area is greater depending on the running time already completed. If traces of wear are visible on the entire diameter of the pump plunger, the fuel pump must be replaced due to too much wear.

If the surface of the pump plunger and/or eccentric is found to have unusual wear, then the propeller gearbox with drive gear and fuel pump must be sent to the authorized distributor or their service center for repair.

- If OK, then reinstall fuel pump with a new gasket.
- Mount the magnetic plug and check for increased metal content. See Fig. 1.
