ALERT SERVICE BULLETIN

Checking of the correct positioning of sealing plug in ignition housing for ROTAX® Engine Type 912 i (Series)

ATA System: 24-20-00 Internal generator

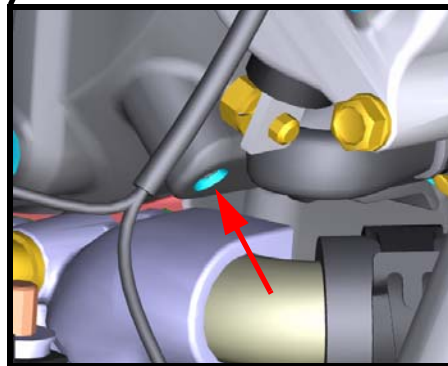
Fig. 1
Sealing plug in ignition housing

Field observation has shown that in isolated cases the sealing plug (see Fig. 1) was not pressed to its correct seating position in the ignition housing. In rare cases this may lead to loss of oil and subsequently loss of lubrication which leads to engine stoppage.
