ALERT SERVICE BULLETIN

Replacement of fuel pump assy. for ROTAX® Aircraft Engine Type 915 i A and 912 i (Series)

ATA System: 73-10-00 Fuel system

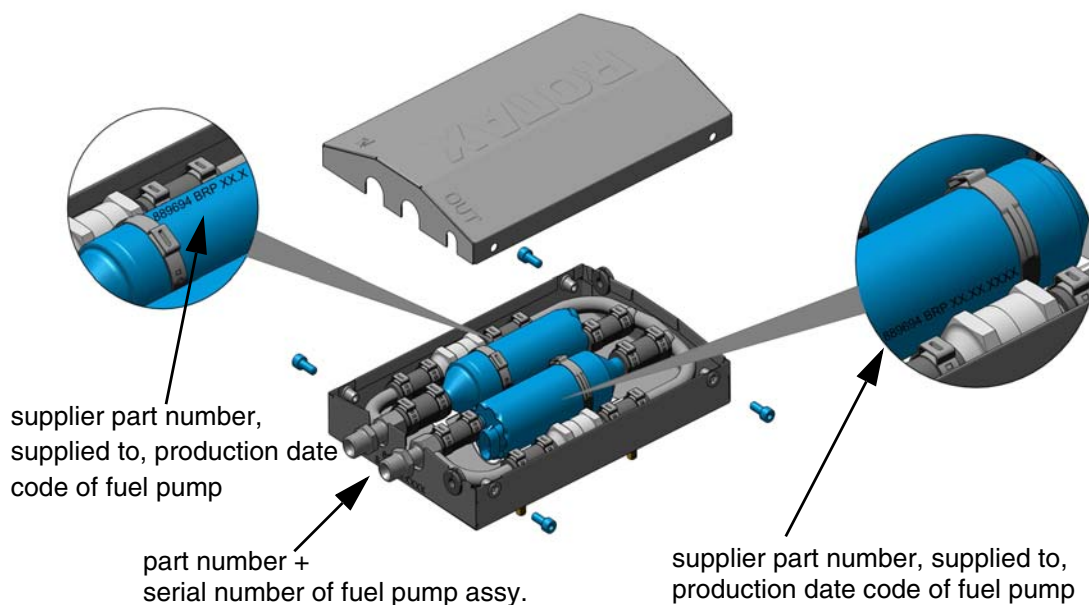
See Fig. 1 for information on how to find the part no. and S/N on the fuel pump assy.
