TECHNICAL NOTE

No. 505-01

Subject : Studs 840 585 (M8 x 177) connecting cylinders to crankcase (8x).

Models affected : Motorised glider engines type 505, engine no. 3,332.580 to 3,332.689.

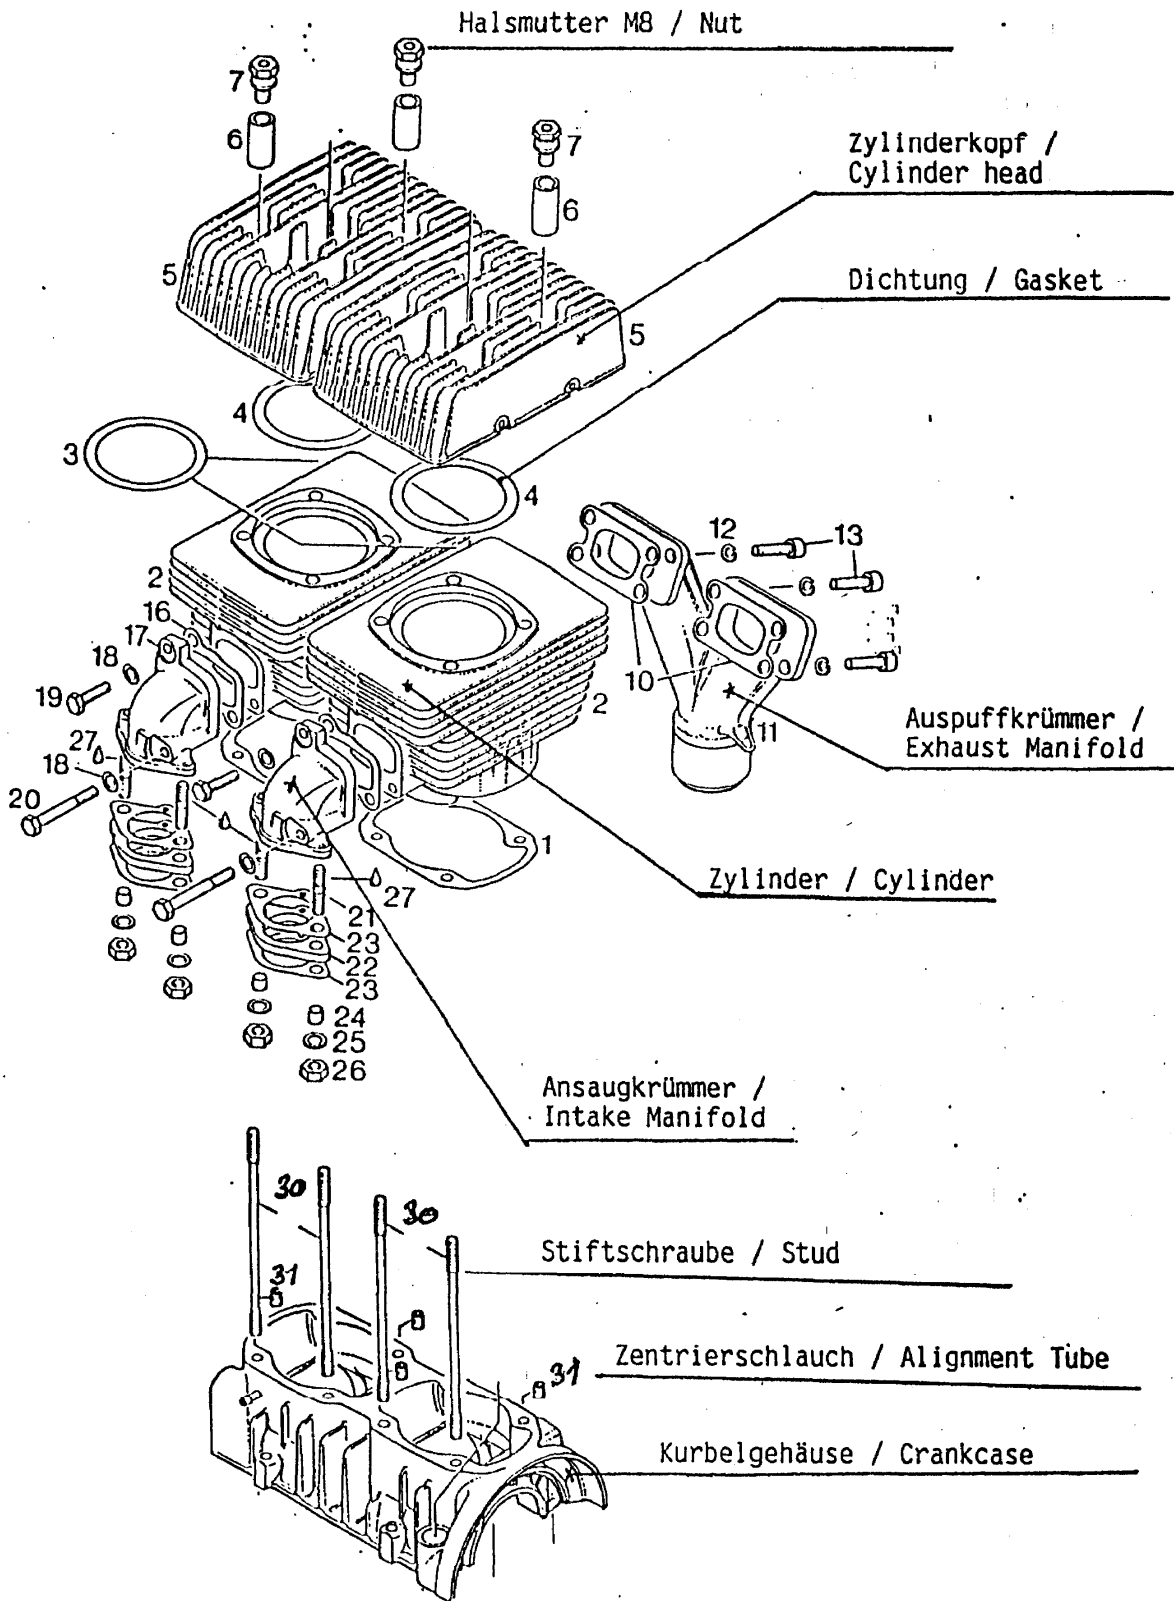
Reason : Breakage of studs.

First indication of broken studs are signs of oilleaks between cylinder and cylinder head. If the socket nuts are also used for suspension purpose or the nuts are not accessible, request and pay attention to advises of aircraft manufacturer.

- 1) Remove socketnuts item 7 (see illustr. on page 3) diagonally and remove spacers (item 6).
- 2) Take off cylinder head. keep cylinders in position.
- 3) Remove cylinder head gaskets and if present, compression shims.
Don't reuse gaskets, always exchange for new ones.
- 4) Carefully remove carbon deposits from top of piston and combustion chamber.
- 5) Exchange studs (item 30) diagonally across.

Attention: Insert alignment tubes (2 per cylinder, positioned diagonally). Fit studs with shorter threaded end right to bottom of tapped blind hole.

- 6) Refit cylinder heads, using new gaskets.

Attention: Fit nuts and compensating washers in same position as prior to disassembly.

Tighten socketnuts diagonally with 20 Nm.
