SERVICE BULLETIN

NEW CHARGING COIL ASSY. WITH SUPPORT FOR ROTAX® ENGINE TYPE 535 SB-535-008 R1

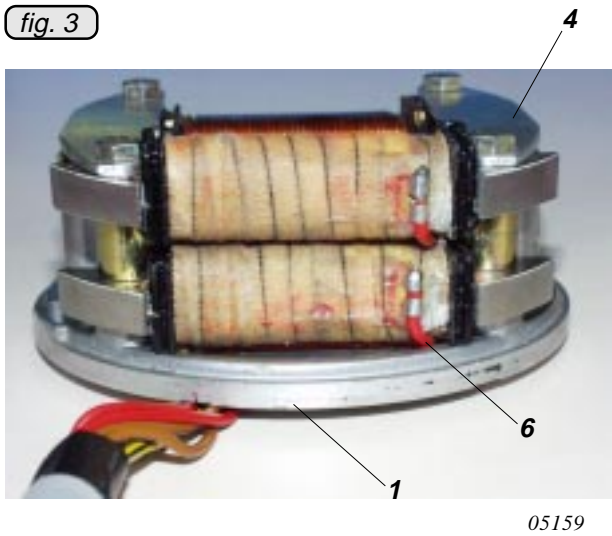
fig. 3

■ **CAUTION:** On the new charging coil (8) the wiring direction of the coil have been turned round, therefore the positioning (position of the charging cable 6) need to be followed as shown in fig. 3. At wrong installed charging coil no high tension output of the relevant electronic box and therefore no ignition spark will be created.

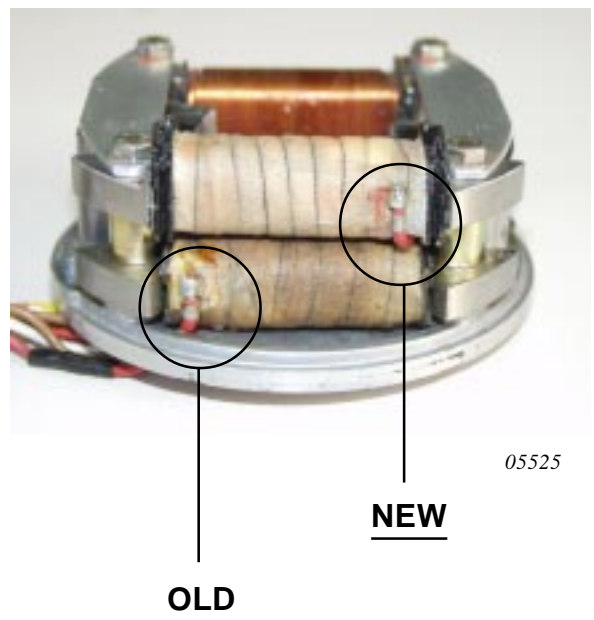
fig. 5

- At replacement of charging coil(s) the armature support has to be renewed too. This is included in the supply volume.
 - An old type and new type charging coil may be fitted together as a working pair (one old style and one new style on same armature plate), but additional care needs to be put on changed positioning of the new charging coil.
- ◆ NOTE: Because of changed wiring at the new type charging coil assy the charging cable soldering point is opposit on the right side (see fig. 5).

If an old type and a new type charging coil is fitted together as a working pair, the charging cable soldering points are at the opposite side (see fig. 5).
