Subject : Fixation of charging coil and lighting coil on armature plate ass'y.

Models affected : Motorised glider engine type 535, all engines of execution A, B and C.

Instruction for disassembly and reassembly of magneto flywheel and
overhaul instruction of coil fixation

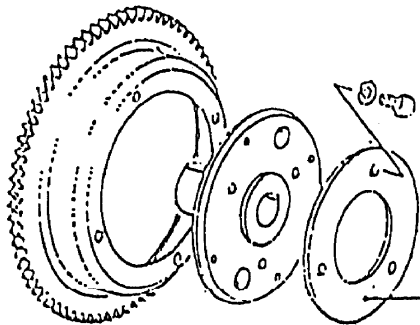
Fig. 1

Cover washer

- 1.1. Remove cover washer (if existing) by unscrewing three bolts
socket spanner, size 13 A/F. Reassembly not forseen.
- 1.2. Fasten flywheel fixture (876 080) with three hex. hd. screws
M8 x 16.
- 1.3. Remove crankshaft hex. nut M22 x 1,5 with socket spanner,
size 30 A/F.
- 1.4. Place protection cap or mushroom-like protector (876.557) to
crankshaft end, fasten puller to flywheel fixture and pull
off magneto housing. Use suitable spanner, size 22 A/F.
