# SERVICE BULLETIN

# EXTENSION OF TIME BETWEEN OVERHAULS (TBO) FOR ROTAX® ENGINE TYPE 912 A (SERIES) SB-912-004 R2

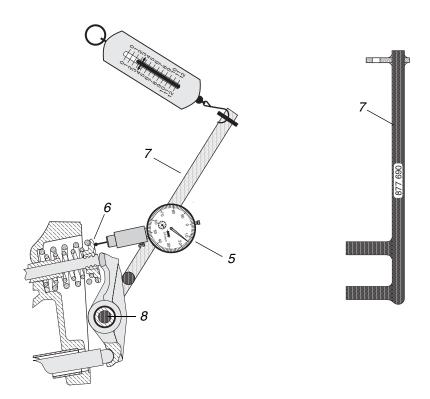
Fig. 1
Check of valve spring tension

- 1. Set cylinder 1 to ignition T.D.C.
- 2. Fit dial gauge (5) to indicate any movement of valve spring retainer (6).
- 3. Fit test lever (7) part no. 877690 in hollow rocker arm shaft (8) and determine the spring tension on both valves by utilizing a spring balance.
- 4. Read value on the balance between 0,2 to 0,3 mm (.008 to .012 in.) indication on dial gauge.
- CAUTION: The value shown on the spring balance must not be below 35 N (26 ft.lb). Valve spring with lower tension must be renewed.
- ◆ NOTE: Read at first try, with force steadily rising, otherwise action of hydraulic tappet will falsify reading. After a misreading wait until valve is closed again completely. Valve closing can be quickened if necessary, by applying pressure to push rod side of rocker arm with the aid of the test lever.
- 5. Check valve spring on all 4 cylinders.
