SERVICE BULLETIN

CHECKING ECCENTERS AND FUEL PUMP PLUNGERS

FOR ROTAX® ENGINE TYPE 912 (SERIES) SB-912-049

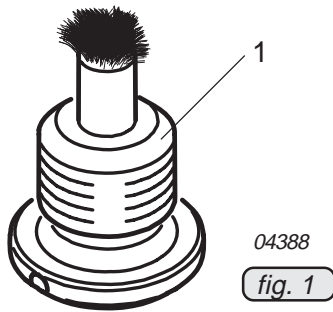
If a quantity of chips (less than 3 mm) is found on the magnetic plug (1) and wear is found on the plunger of the fuel pump, then the eccentric and the fuel pump must be replaced.

Steel chips in small quantities as shown in Fig. 1 are acceptable as long as the layer thickness is less than 3 mm. If the findings are unclear, the oil circuit must be flushed and a new oil filter installed.

- Carry out a ground run with the new oil filter and check oil filter mats again for chips according to the current maintenance manual. If an unusual quantity of chips is found again, the cause must be found and the damage corrected.

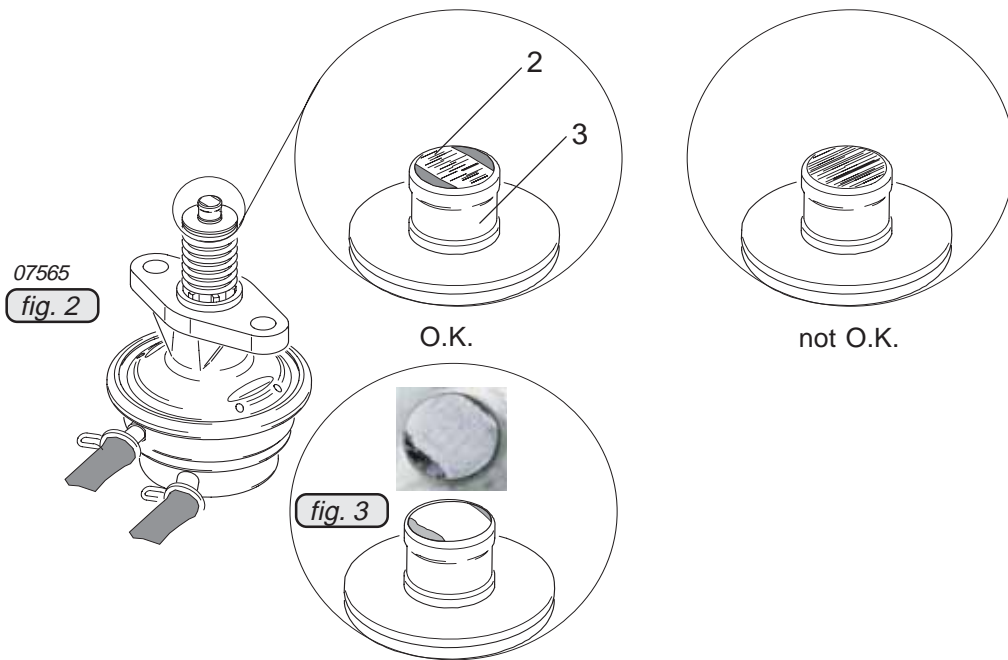
- Remove fuel pump
- Detailed check of the surface (2) of the fuel pump plunger (3). The contact surface with the eccentric must have no fretting or scoring marks. Wear traces that appear slight are permissible. See Fig. 3. The width of the contact area is greater depending on the running time already completed. If traces of wear are visible on the entire diameter of the pump plunger, the fuel pump must be replaced due to too much wear.

◆ **NOTE:** Light wear marks are normal and are not considered.

If the surface of the pump plunger and/or eccentric is found to have unusual wear, then the propeller gearbox with drive gear and fuel pump must be sent to the authorized distributor or their service center for repair.
