SERVICE BULLETIN

CHECKING OF MAGNETIC PLUG ON ROTAX_® ENGINE TYPE 912/914 (SERIES) SB-912-051UL SB-914-034UL

MANDATORY

CHECKING OF MAGNETIC PLUG ON ROTAX® ENGINE TYPE 912/914 (SERIES) SB-912-051 SB-914-034

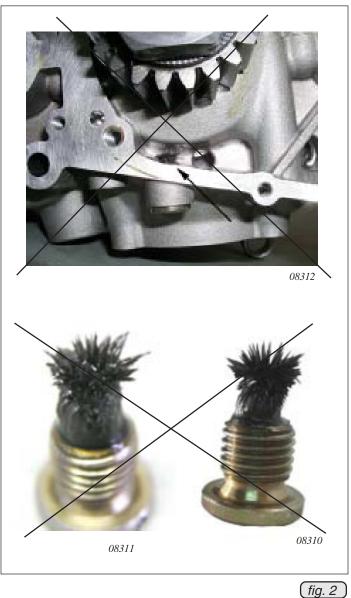
fig. 1

- 1. Remove the magnetic plug according to relevant Maintenance Manual.
- 2. Inspect magnetic plug in accordance with procedure in relevant Maintenance Manual.
- CAUTION: If a greater quantity of metal particles (more than 3 mm (1/8")) is detected, consultation of an authorized distributor regarding further action is necessary. The engine must not be taken into operation until the cause has been identified and eliminated.
- Restore aircraft to original operating configuration.
- Connect negative terminal of aircraft battery.

acceptable

not acceptable
