SERVICE BULLETIN

REPLACEMENT OF FUEL PUMP FOR ROTAX_® ENGINE TYPE 912 (SERIES) SB-912-053

MANDATORY

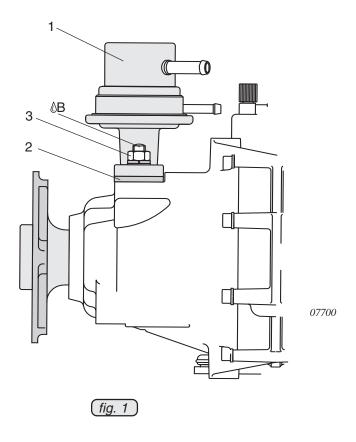
Due to high fuel pressure, caused by exceeding pressure in front of the mechanical fuel pump (e.g. due to an electrical fuel pump), in limited cases a deviation in the fuel supply could occur. This can result in exceeding of the fuel pressure and might cause engine malfunction and/or massive fuel leakage.

(see Fig.1)

- 1. Remove fuel pump (1).
- 2. Gasket (2) replaced by new part.
- CAUTION: Install new gasket supplied with new fuel pump. Do not reuse old gasket.
- ◆ NOTE: On the sealing surfaces of the gearbox housing and the fuel pump no sealing compound has to be used.
- Install fuel pump.
- 4. Tighten uniformly hex. nuts (3) with LOCTITE 243. Tightening torque 15 Nm (133 in.lb).
- ♦ NOTE: The additional use of LOCTITE 243 should be applied at each removal/replacement of the fuel pump and/or gasket. A rework of already installed fuel pumps part no. 892542 and 892546 is not necessary.
- 5. Install fuel line.
