SERVICE BULLETIN

CHECKING OR REPLACEMENT OF FLEXIBLE FUEL LINE FOR ROTAX® ENGINE TYPE 912 (SERIES) SB-912-054

MANDATORY

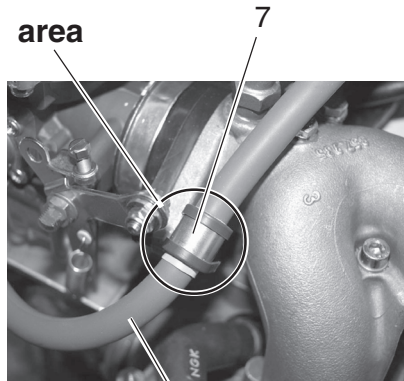
Fig. 1

Visual inspection of the fuel line (1) in the area clamp (7) and both ends of the yellow protection cover. (see Fig. 1)

◆ **NOTE:** A possible crack can be observed by careful bending of the fuel line. If you notice cracks or porosity then you need to replace the fuel line in accordance section 3.1.2.

2. Install both cable clamp (7) in accordance with Fig.1 on the fuel line.

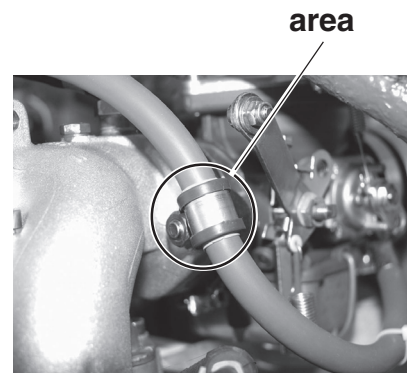
Due to a chemical reaction of the adhesive (in the area of the yellow position marks on the firesleeve) porosity and/or cracks on the firesleeve can occur.

Fuel leakage within this area is not an issue, as only the fireproof protection hose is affected and the fuel is routed in a wire braid reinforced teflon hose.
