SERVICE BULLETIN

CHECKING OF THE CRANKSHAFT JOURNAL (POWER TAKE OFF SIDE) FOR ROTAX® ENGINE TYPE 912 AND 914 (SERIES) SB-912-059 SB-914-042

MANDATORY

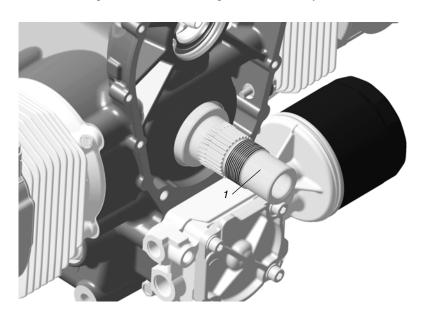
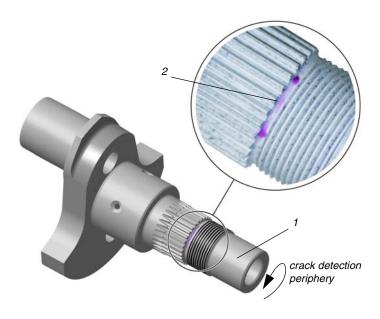
Fig. 1 crankshaft journal

Due to a deviation in the manufacturing process some crankshafts may have a crack formation occur on the power take off side. These cracks can cause a breakage of the crankshaft support bearing and may lead to engine stoppage.

- Detailed crack detection in the area (2) of the thread runout using penetration test. Perform this
 test in accordance to the requirements of the applicable aviation authority in your region for
 non destructive testing (NDT) and according to DIN EN 571 or equivalent.

- 1 crankshaft
- 2 detailed crack detection

- NOTE: Protect the crankcase against contamination by the test material.
- CAUTION: In case of crack or doubt contact your aircraft manufacturer and your nearest authorized ROTAX aircraft engine distributor. The engine must not be taken into operation until the cause has been identified and eliminated.
