SERVICE BULLETIN

Inspection and/or replacement of the valve push-rod assy., rocker arm left and rocker arm right for ROTAX® Engine Type 912 i, 912 and 914 (Series)

ATA System: 72-30-00 Cylinder head

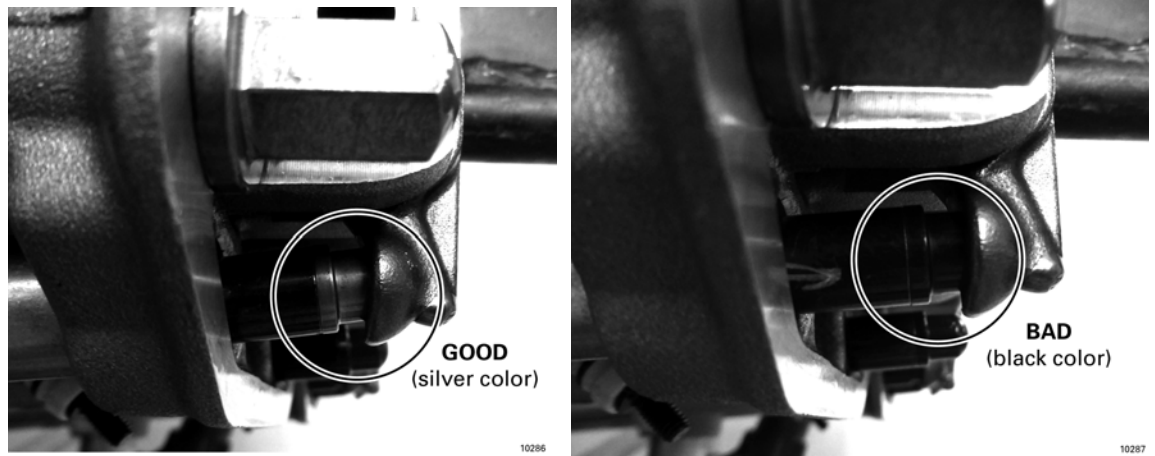
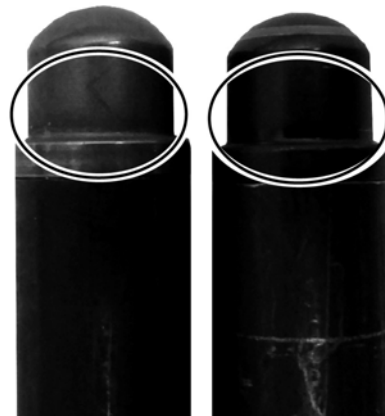
Fig. 1
Visual inspection

Due to deviations in the manufacturing process of the valve push-rod assy., partial wear on the rocker arm ball socket may occur. This wear might lead to a rocker arm cracking / fracture which in consequence may lead to a malfunction of the valve train. Possible effects are rough engine running or an unusual engine operating behaviour.

Perform visual inspection of all push-rod ball sockets on all cylinder.
 Check for color. See Fig. 1.

| Color | Evaluation |
|---|---|
| Silver surface | Valve push-rod is OK. No further action required for this valve push-rod. |
| Black surface | Valve push-rod is NOT OK. See section. 3.1.3) Replacement of affected parts. |

GOOD
(silver color)

BAD
(black color)

3.1.3) Replacement of affected parts on affected cylinder positions (only in case visual inspection is NOT passed OK)
