SERVICE BULLETIN

CHECKING OR REPLACEMENT OF THE EXHAUST BEND

ON ROTAX® ENGINE TYPE 914 (SERIES) SB-914-017 R1

MANDATORY

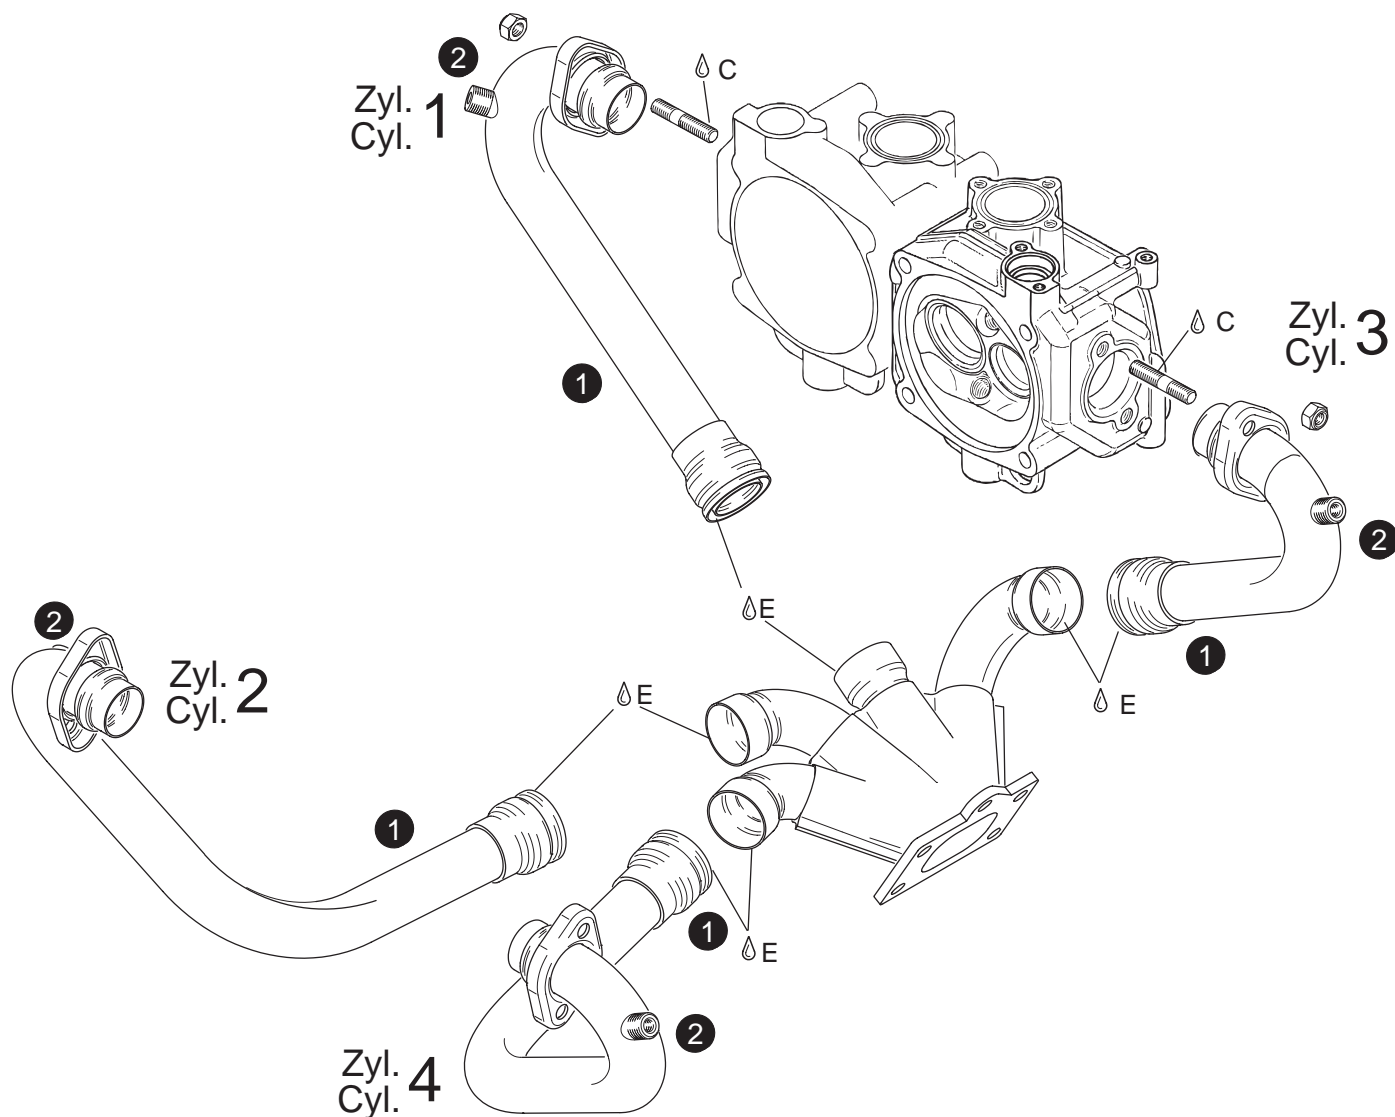
fig. 1

One or more of the following could result in formation of cracks on the exhaust bends:

Vibrations, impacts, forces, thermal strain etc. could cause cracks on the exhaust bends.

◆ **NOTE:** Scrutinize the exhaust bends for exterior traces of smoke, cracks and other faults especially about the EGT-terminals (2). (see fig. 1)

- If cracks are detected replace the exhaust bend in accordance with the relevant Maintenance Manual.
