Checking of the axial clearance of wastegate shaft on turbocharger for ROTAX_® Engine Type 915 i (Series)

ATA System: 78-10-00 Exhaust system

MANDATORY

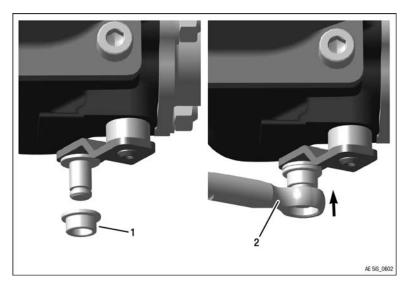
Fig. 6
Installation bushing

1 Bushing 2 Pressure control rod

Step	Procedure
1	Lubricate the control rod bar bushing (1) with LOCTITE ANTI SEIZE 8151.
2	Place the bushing (1) onto the pin with the bushing collar facing towards the wastegate arm.
3	Place the pressure control pin (2) over the bushing.
