SERVICE BULLETIN

CHECK OF SUPPORT BEARING ON THE CRANKSHAFT AND OF THE BEARING BUSHING IN THE PROPELLER GEARBOX ON ROTAX® ENGINE TYPE 912/914

SB-912-046

SB-914-031

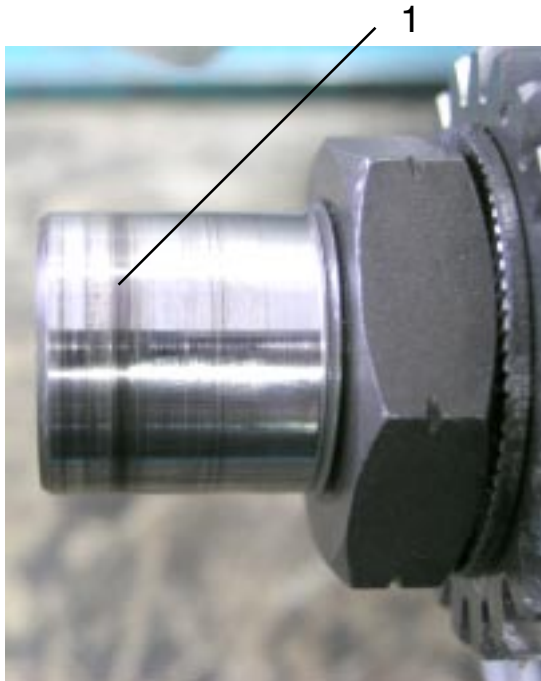
Fig. 1

In limited cases a production deviation of the crankshaft bearing in the gearbox cover may lead to reduced bearing clearance which may result in scoring marks.

If discoloration and grooves (1) are not removeable with Scotch Brite, engine must be sent to the authorized distributor responsible for the distribution area.

- If necessary clean the crankshaft stub with Scotch Brite until no discolouration is there. If the discolouration cannot be removed, engine must be sent to the authorized distributor responsible for the distribution area for repair/overhaul.
- On signs of scoring marks in the bearing bushing replace the whole propeller gearbox and check the oil filter for metal chips. If unusual marks of metal chips are detected in the filter mat, empty and clean the oil tank. Carry out an oil change. The replaced propeller gearbox must be sent to the authorized distributor responsible for the distribution area.
- Reinstall the checked propeller gearbox.
- If a new gearbox is required, the drive gear on the crankshaft must be replaced too.

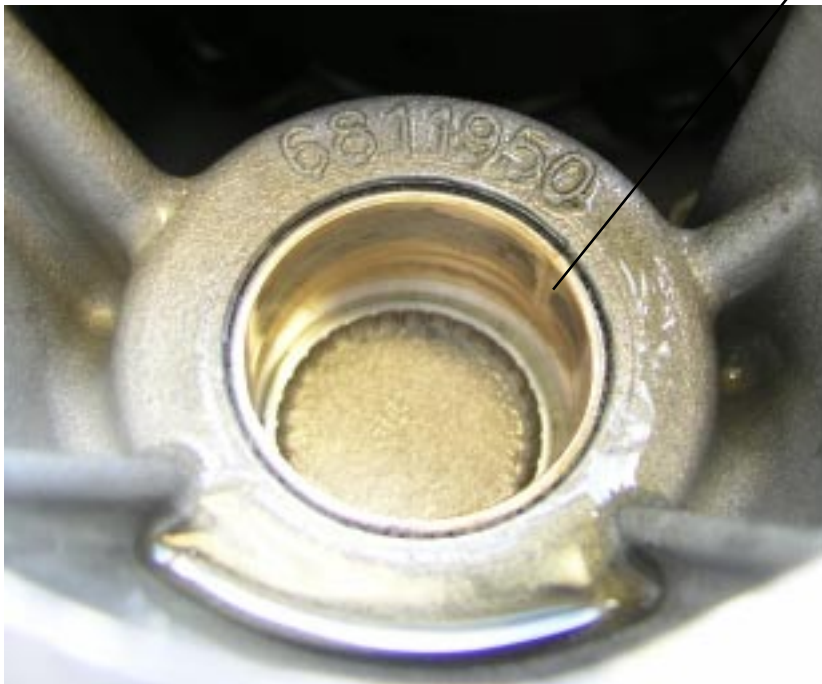
Fig. 2

Replacement of propeller gearbox required if unusual scoring (2) in the bearing bushing is discovered.

◆ **NOTE:** Drive gear and dog gear are paired and have the same s/n and therefore must be replaced only combined.
