Ignition unit of ROTAX engine 912 UL

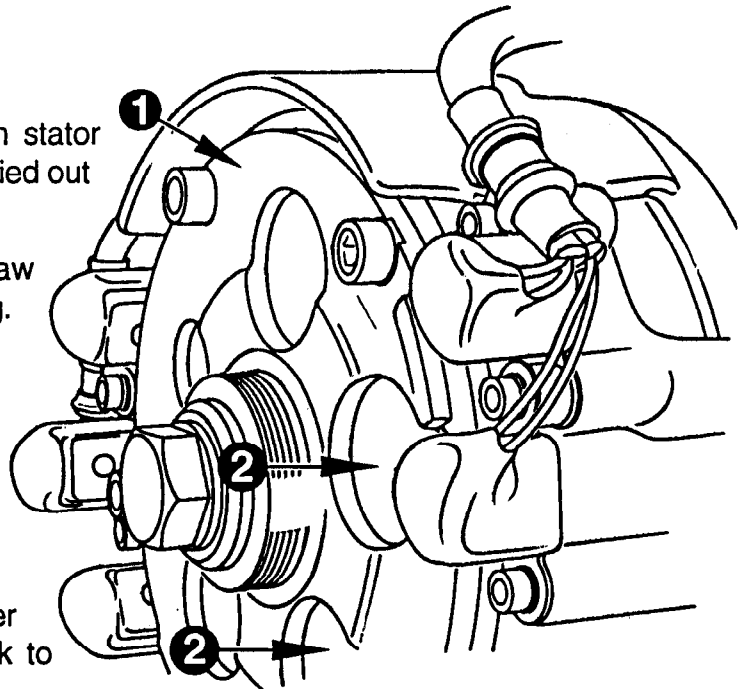
As known from experience, inadequate ground connection could arise between stator and ignition housing on the engine type 912 UL.

Disconnect battery. No need to withdraw magneto housing ① with magneto ring. Remove at least 2 of the 4 Allen screws ③ and lock washers for stator attachment via the openings ② in the magneto housing.

■ **ATTENTION:** Make absolutely sure that no foreign matter (lock washer or screws) will stick to the magneto ring.
