AIRCRAFT ENGINES

SERVICE INSTRUCTION

CHANGE OF THE EXHAUST GASKET ON ROTAX® ENGINE TYPE 582 UL, MODEL 90/99 AND ON ROTAX® ENGINE TYPE 618 UL SI-2ST-002

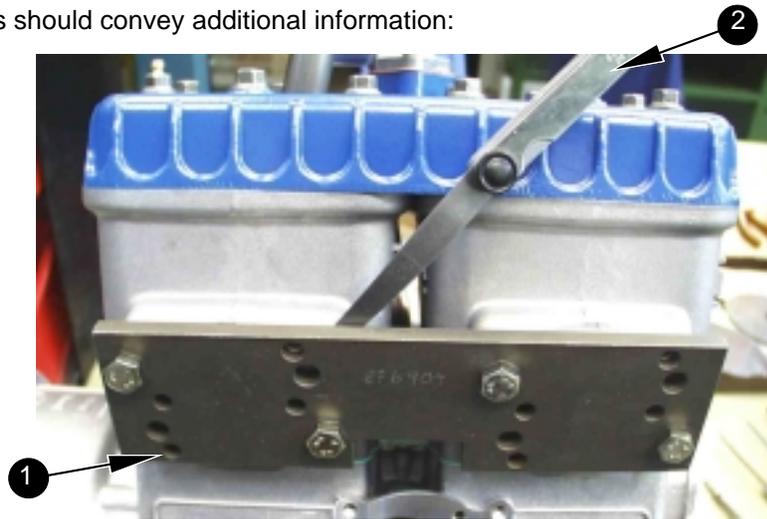
Fig. 1

- Verify alignment of the cylinders by use of the listed alignment tool (1) or with the original exhaust manifold and check with a feeler gauge (2). At a gap on the mating face in excess (of max. 0,3 mm/0,012 in) reset the cylinders (see fig. 1).

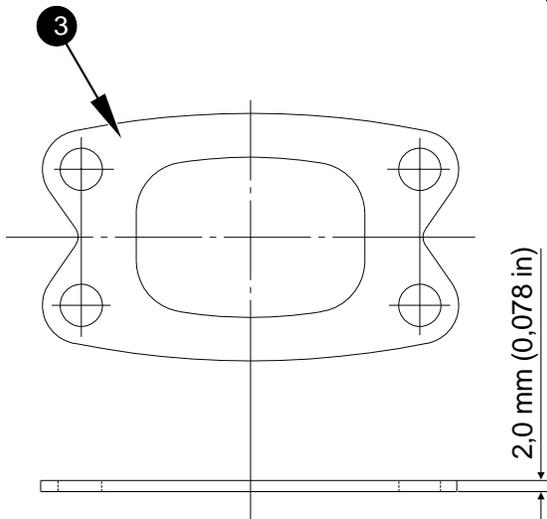
Exhaust gasket
OLD version
Part no. 850.630

▲ **WARNING:** Fit either only old or only new type exhaust gaskets but never mix old and new gaskets as they are of different thickness (see fig. 3 and 4).

When fitting the exhaust gasket make sure to use only gaskets of the same thickness (see fig. 3 and 4).

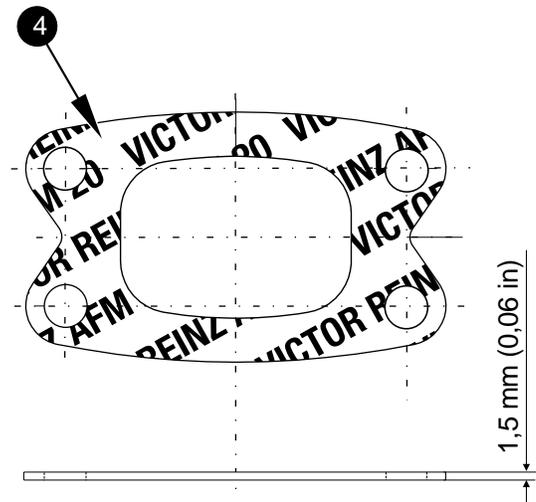
Fig. 2

◆ **NOTE:** Fit the new exhaust gaskets (4,6) with the printed side towards exhaust manifold.

Exhaust gasket
NEW version
Part no. 850.633

- Attach the new exhaust gaskets (4,6) and exhaust manifold with the six Allen screws M8x30 (582 UL mod. 90/99) or with eight Allen screws M6x25 (618 UL) along with new lock washers.

- Tighten the 6 screws M8x30 (582 UL mod. 90/99) crosswise to 22 Nm or 195 lb.in.

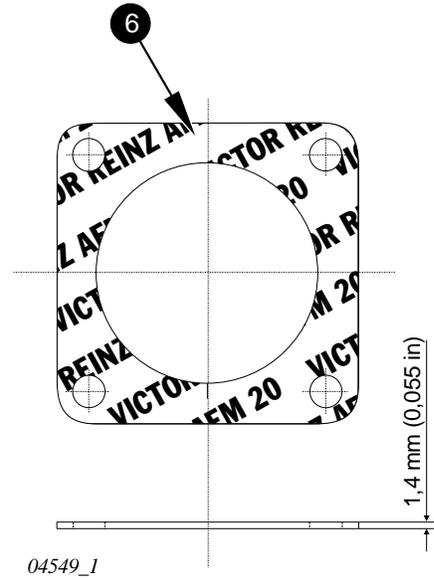
Fig. 3

Exhaust gasket
NEW version
Part no. 850.552

- Tighten the 8 screws M6x25 (618 UL) crosswise to 10 Nm or 90 lb.in.
