SERVICE INSTRUCTION

INSTALLATION OF ROTARY WATER PUMP SEAL / PUMP IMPELLER

SI-912-001

SI-914-001

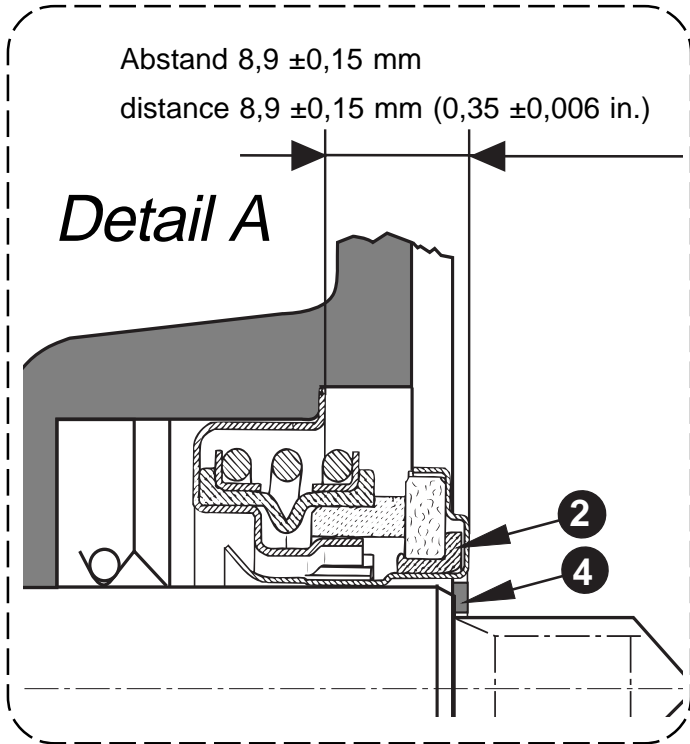
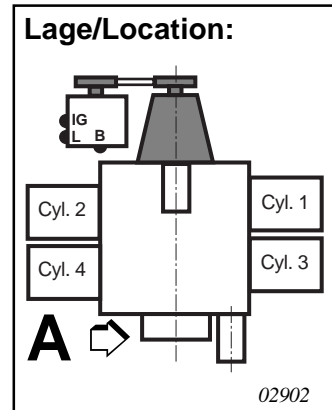
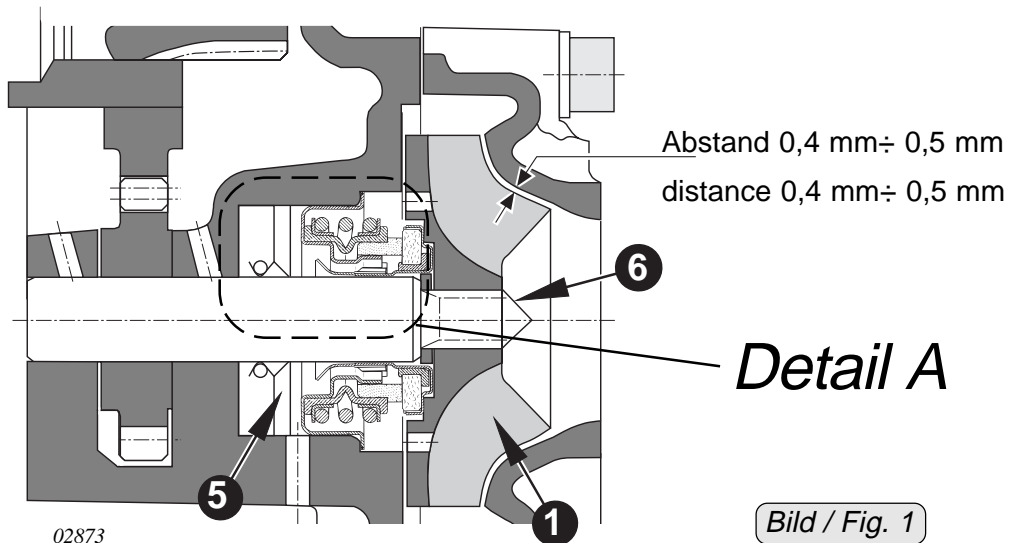
Bild / Fig. 1

- If **distance (shown in fig. 1) is not within 8,9 ±0,15 mm (0,35 ±0,006 in.)**, the seal spring has been over-compressed and the seal must be replaced.

cross-section of waterpump

- The oil seal ⑤ must be replaced as per the instructions found in the current relevant Maintenance Manual and/or Repair Manual (ICR-Manual).
- The **new rotary seal (part no. 850.945) ②** and the **new washer (part no. 926.273) ④** must be installed as per the instructions found in the current relevant Maintenance Manual and/or Repair Manual (ICR-Manual). The **new rotary seal insertion punch (part no. 877.259) ③** must be used. Very careful handling and installation of the rotary seal is vital in preventing coolant loss.

- Ensure that water pump shaft is parallel to seal bore during installation.
- If the shaft is not parallel to the bore when installed, the edge of the shaft can dimple the soft material of the seal bore, reducing the sealing effectiveness of the press fit. To increase the effectiveness of the press fit **between the pump shaft ⑥ and the seal, a small amount of LOCTITE 243 adhesive** must be applied around the shaft.

- Impeller of new design (part no. 922.224) **①** must be installed with new rotary seal. Installation as per instructions in the current relevant Maintenance Manual and/or Repair Manual (ICR-Manual).
- The **distance** (shown in fig. 1) **between 0,4 mm ÷ 0,5 mm (0,016 in. ÷ 0,02 in.)** must be verified in accordance with the current, relevant Maintenance Manual and/or Repair Manual (ICR-Manual). If measurement is not within manufacturers recommendations the installation procedure wasn't followed properly and the rotary seal and oil seal is no longer serviceable. The seals must be removed and a new rotary seal and a new oil seal must be installed as per manufacturers recommendations.
- Reconnect the aircraft battery.

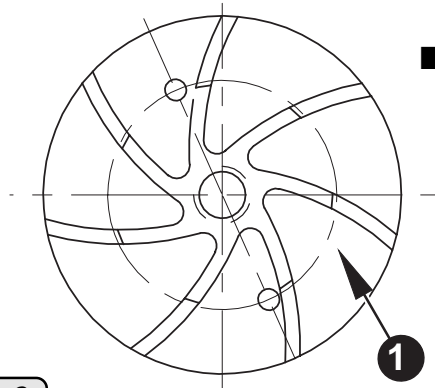
Bild 2/ fig. 2 02722

The illustration below shows the new impeller with 2 holes:

■ **ATTENTION:**The impeller can only be utilized for the new rotary seal (part no. 850.945).

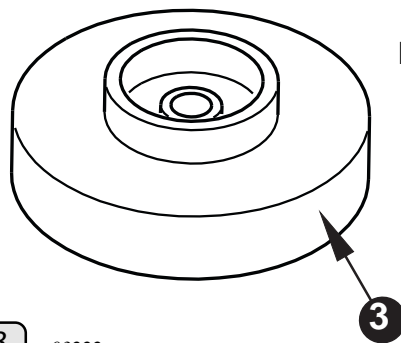
Bild 3/ fig. 3 03222

The illustration below shows the new insertion punch:

■ **ATTENTION:**The new insertion punch can only be utilized for the new rotary seal (part no. 850.945).

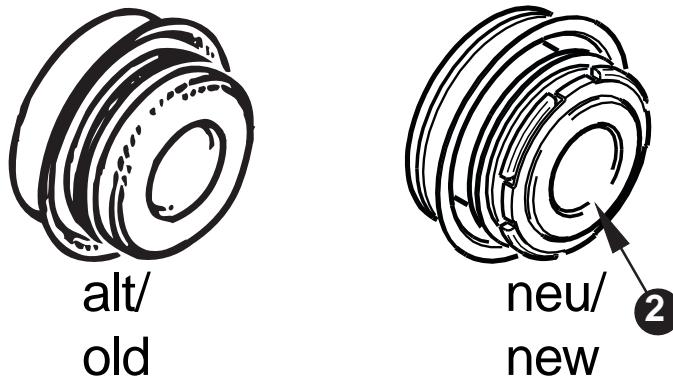
Bild 4/ fig. 4 03502

Feedback from the field indicates that in the course of maintenance the installation of the rotary seal has not been done proper. Improper installation can cause damage on the rotary seal, possibly resulting in leakage of coolant.

The illustration below show the rotary seal of the old and new design:
