Grounding cable for electronic module of ROTAX Engine Series Type 912 A

Subject: Inspection of electronic module on engine series 912 A. Specifically, review cable lug connection onto grounding cable.

AIRWORTHINESS DIRECTIVE

No. 80

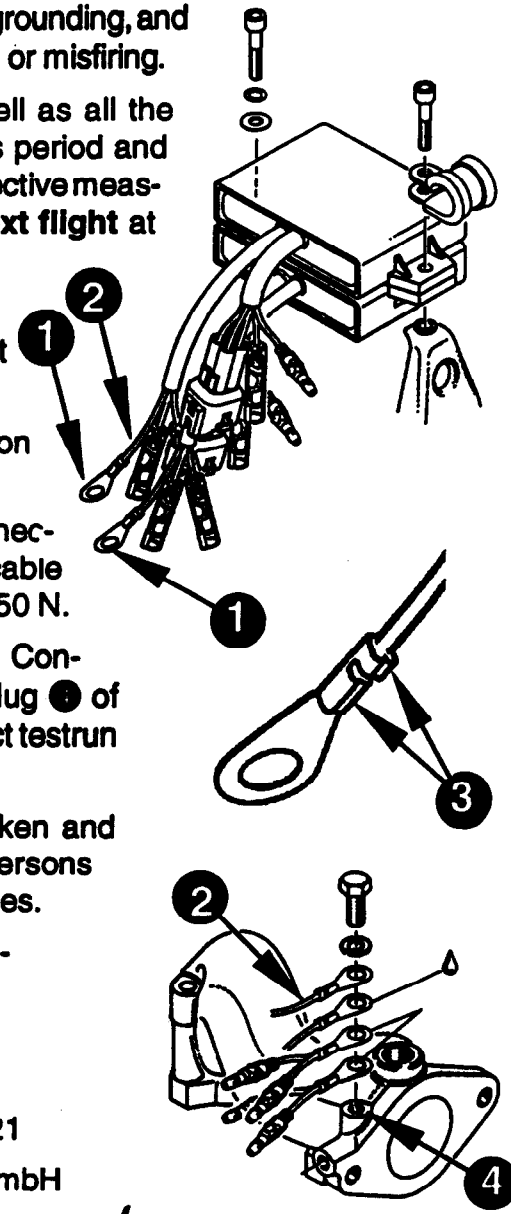
In some cases the cable lug ❶ was not fitted tightly enough onto the grounding cable ❷, resulting in poor grounding, and possibly leading to engine stoppage or misfiring.

Remedy: To guarantee the sufficient crimping ❸ of the cable lug a pull-off test with 50 N has to be conducted.

◆ **NOTE:** The specified extraction force is 100 + 200 N.

At occurrence of an inadequate connection, correct by crimping on new cable lug, part no. 964 056 and test with 50 N.

Apply Lithium grease on cable lug. Connect both grounding cables ❷ on lug ❸ of the right intake manifold and conduct testrun and ignition check.

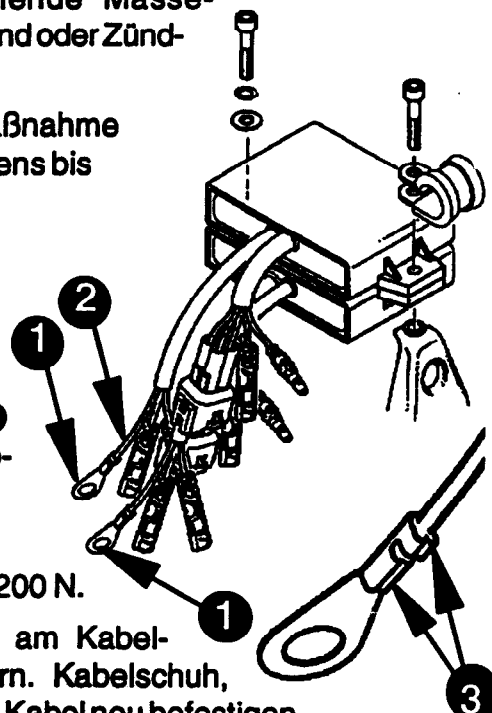
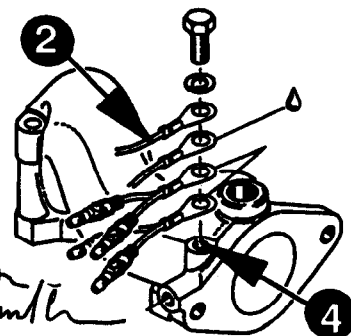
In einigen Fällen war der Kabelschuh ❶ nicht ausreichend auf das Massekabel ❷ aufgepreßt. Die unzureichende Masseverbindung könnte ungewollt Motorstillstand oder Zündaussetzer bewirken.

Abhilfe: Um sicherzustellen, ob die Krimpung ❸ des Kabelschuhes ausreicht, ist ein Abziehversuch mit 50 N durchzuführen.

◆ **HINWEIS:** Die effektive Ausziehungskraft liegt bei ca. 100 + 200 N.

Sollte eine unzureichende Verbindung am Kabelschuh vorliegen, ist dieser zu erneuern. Kabelschuh, Teile-Nr. 964 056 mit der Krimpzange am Kabel neu befestigen und einen 50 N Abziehversuch durchführen.

Kabelschuhe mit Lithium Seifenfett einstreichen. Beide Masseleitungen ❹ am Butzen ❺ des rechten Ansaugstutzens befestigen und einen Motorprüflauf mit Magnetcheck durchführen.
