Rotax Motor Type 914 F Serie, Kontrolle / Austausch des Wastegate-Seilzuges

Rotax engine type 914 F series, check / replacement of the wastegate servo cable

Check / replacement of the turbocharger wastegate servo cable (part no. 897.940).

All versions of engine **type 914 F series from S/N 4,420.002 up to and including S/N 4,420.127.**

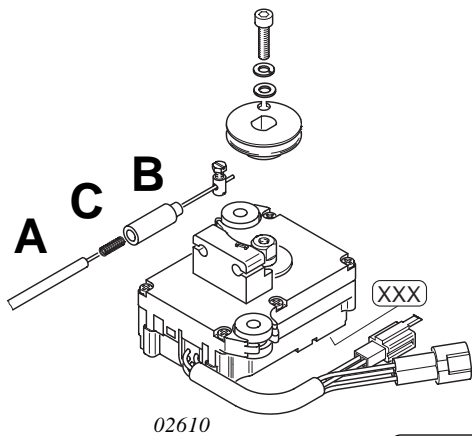
Bild / Fig. 2

Ensure that the pressure spring in the spring socket is in the right position. See Fig. 2.

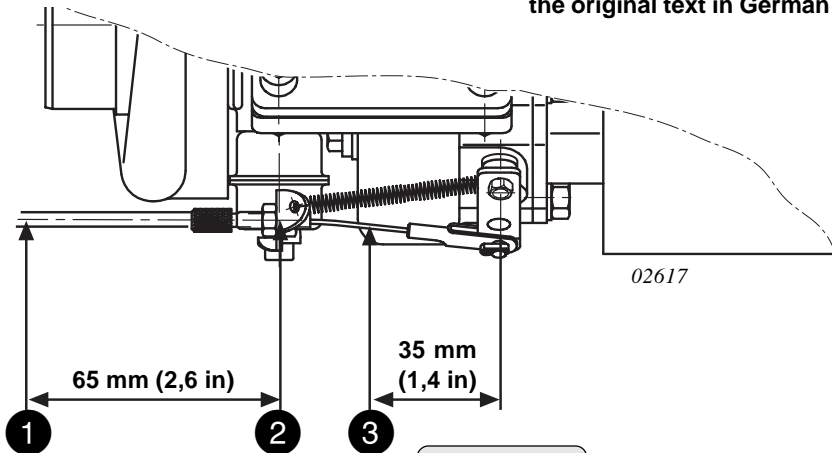
Bild / Fig. 1

Following temperatures must be measured on the positions set out in figure 1 and must **not** be exceeded during take off and after engine stop (heat accumulation).

pos.	description	temperature
①	cable conduit	max. 120 °C (250 °F)
②	cable support	max. 120 °C (250 °F)
③	wire rope	max. 140 °C (280 °F)

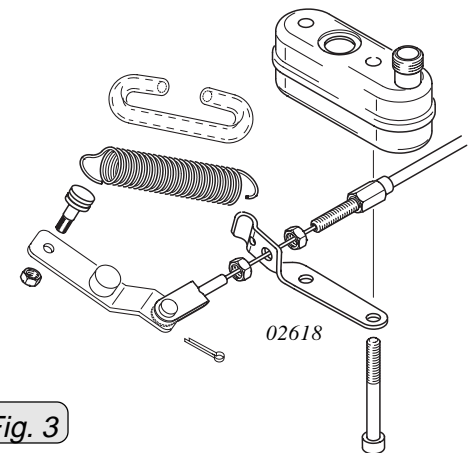
Bild / Fig. 3

3.1) replacement of servo cable (see fig. 1, 2 und 3)
