SERVICE BULLETIN

<u>CHECKING OF</u> OIL PUMP ATTACHMENT SCREW FOR ROTAX_® ENGINE TYPE 912 A (SERIE) SB-912-034

MANDATORY

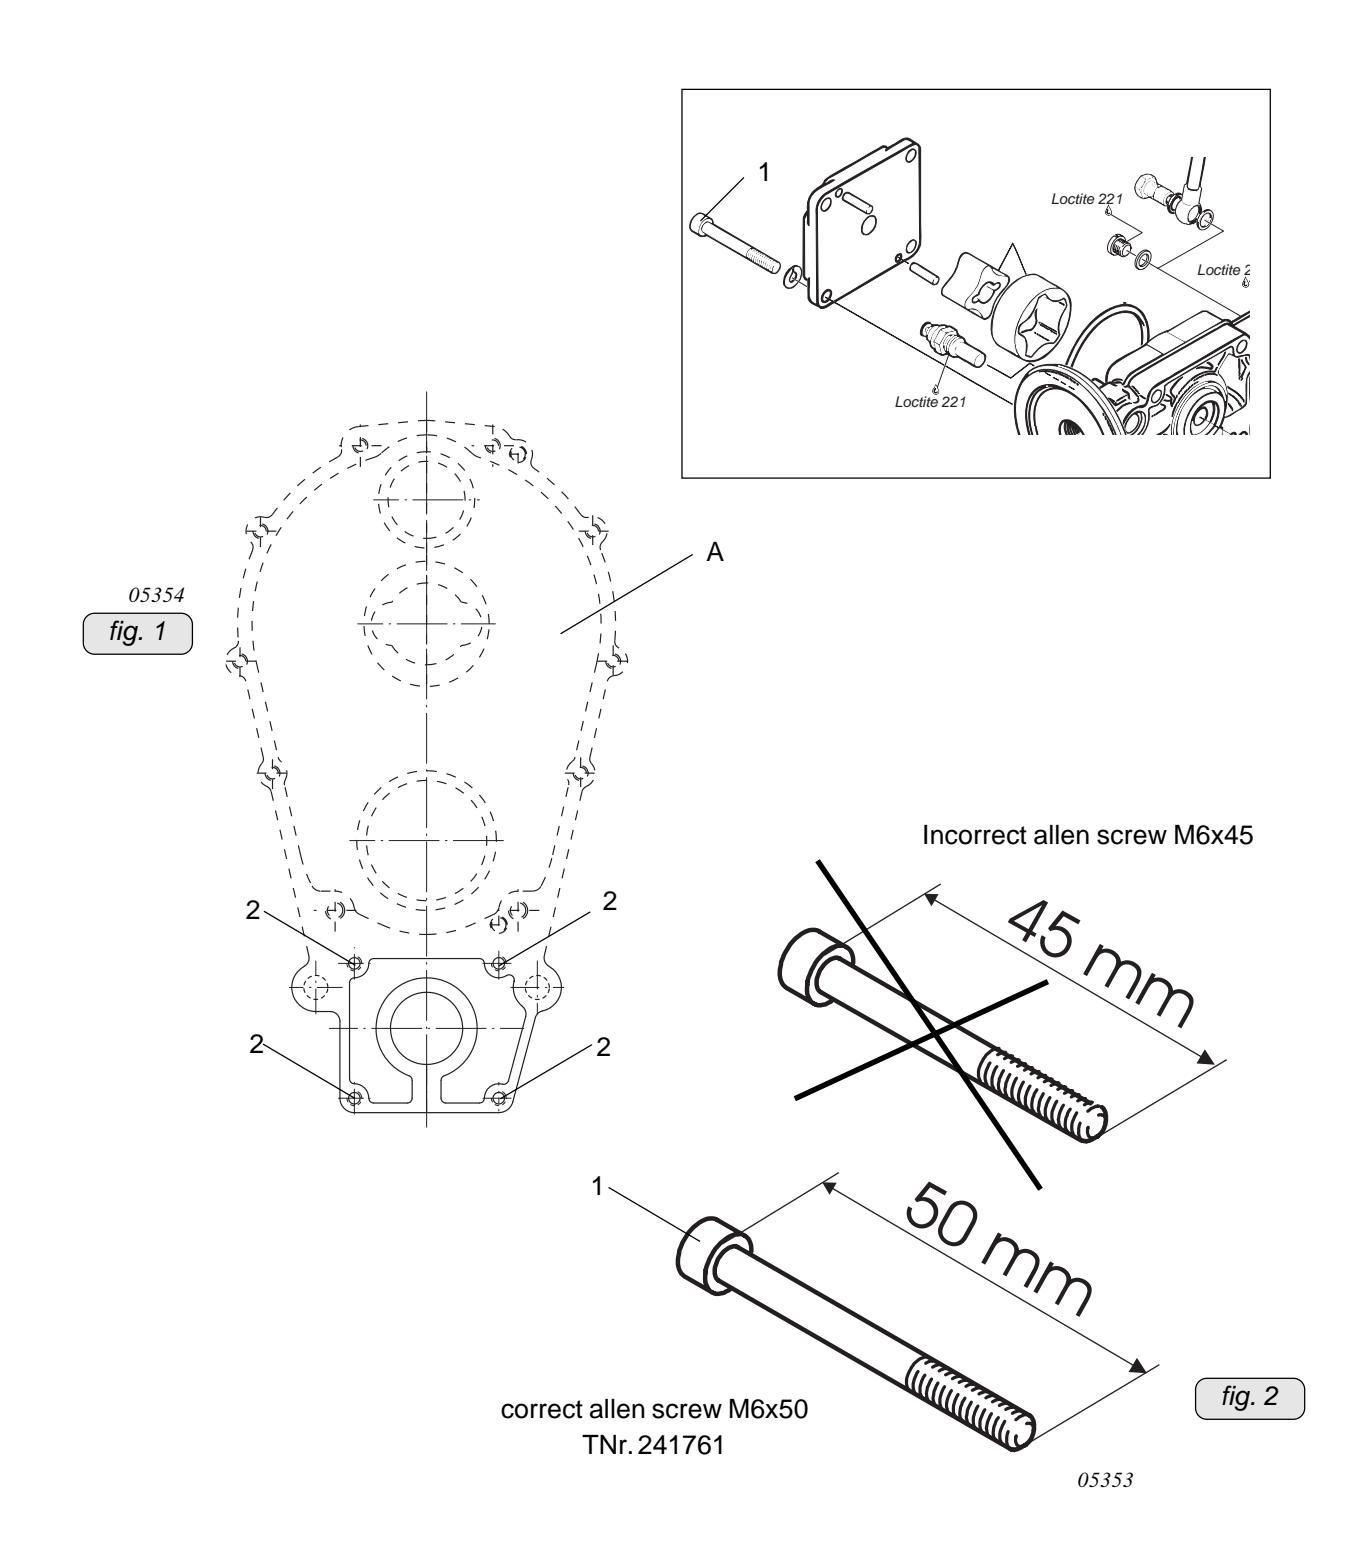
Allen screws M6x45 instead of machine allen screw M6x50 part no. 241761 were added to oil pump assembly part no. 889590.

- Remove 4 allen screws (1) and determine screw lenght. Screws of 50 mm lenght re-fit according to the Maintenance Manual. At a deviation in length, carry out the following.
- Remove the oil pump assy.
- Clean all 4 internal threads M6 (2) on crankcase (A); and inspect for damage.

- If the threads (2) on the crankcase should be found damaged, then repair them by means of threaded inserts from Heli Coil® or equivalent.
- ▲ WARNING: This work shall only be carried out by qualified persons approved by the respective Aviation Authority. Pay attention to the threaded insert manufacturer's specifications and instructions.

- CAUTION: Check screw length of oil pump attachment (see fig.2)
- The installation has to be performed in accordance with the relevant Maintenance Manual.
