SERVICE BULLETIN <u>CHECKING OR REPLACEMENT OF</u> <u>TENSION SPRINGS ON EXHAUST SYSTEM</u> <u>FOR ROTAX</u> <u>SB-2ST-001</u>

MANDATORY

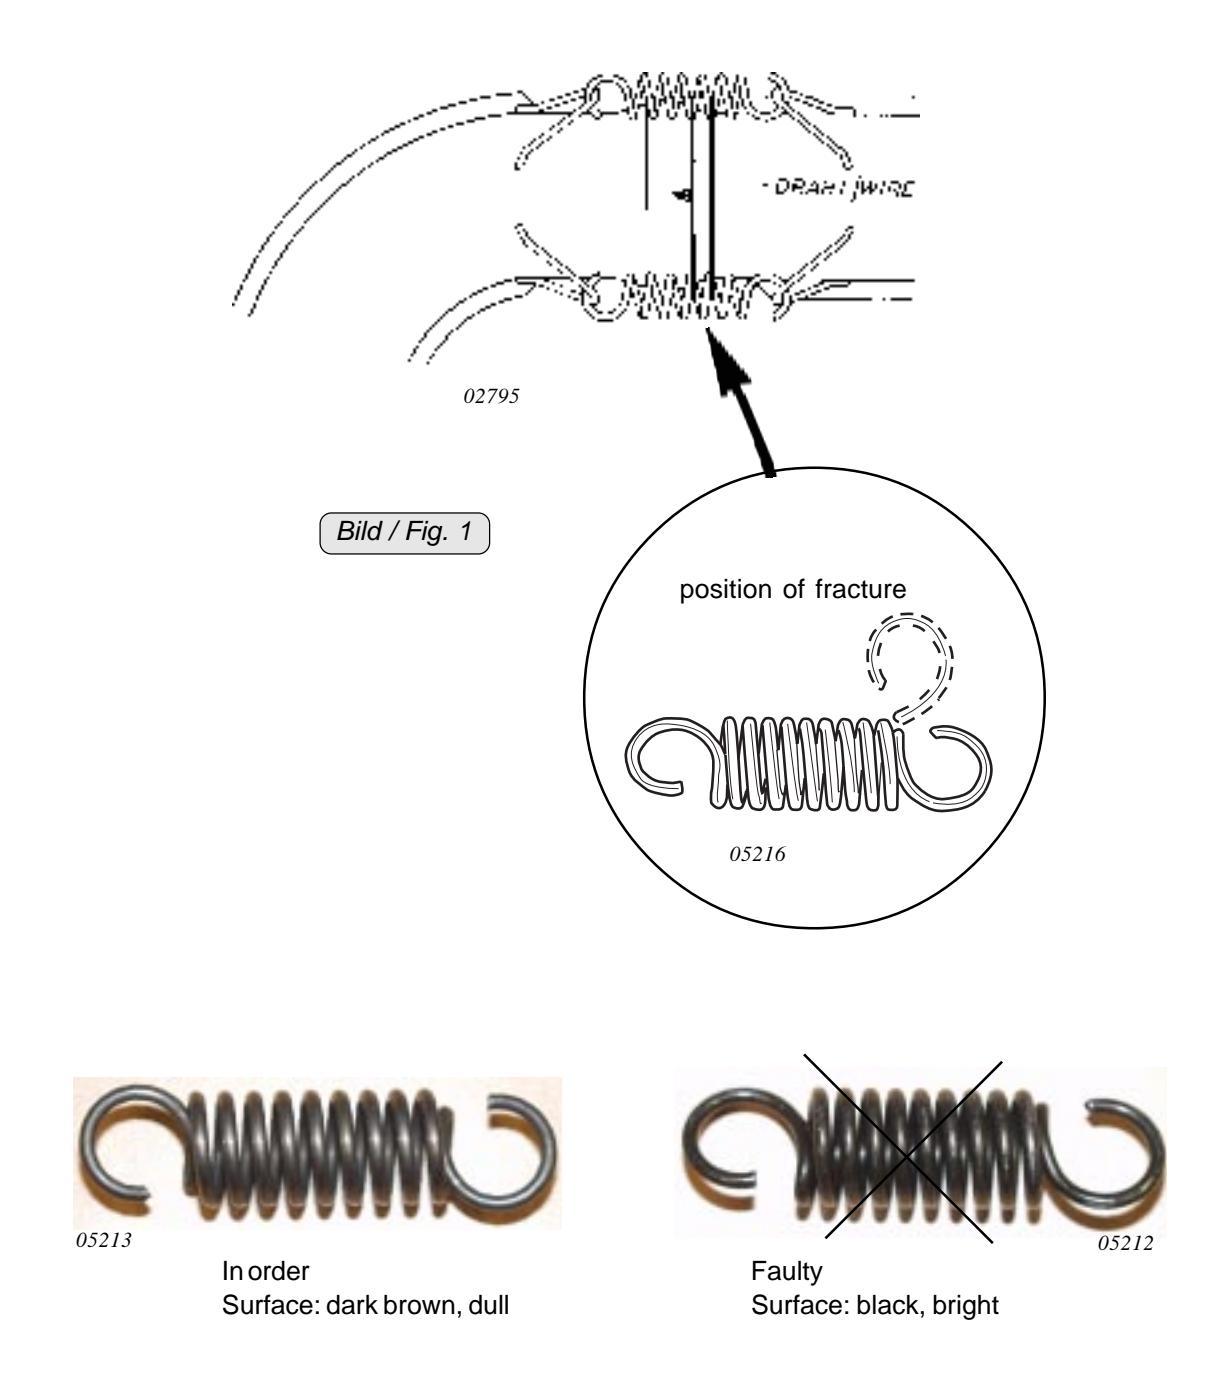
Deviations of material could result in cracking of the exhaust springs during installation or in operation. In a few cases, spring fractures were detected during installation and in operation.

The affected (faulty) tension springs can be identified by black, bright surfaces.

- Lubricate ball joint with heat-resistant lubricant (LOCTITE_® "Anti-Seize" or equivalent).
- Install new tension springs with appropriate tools.
- Exhaust springs shall be secured against loss and vibrations with wire. See Fig. 1.
- Restore aircraft to original operating configuration.
- Connect negative terminal of aircraft battery.
