AIRCRAFT ENGINES

SERVICE INSTRUCTION

REPLACEMENT OF THE CIRCLIP IN THE SPRAG CLUTCH HOUSING ON ROTAX® ENGINE TYPE 912 AND 914 (SERIES)

SI-912-006 R1

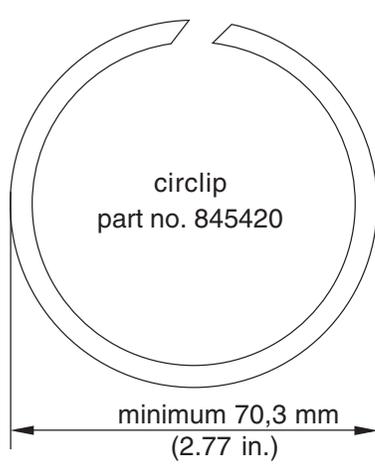
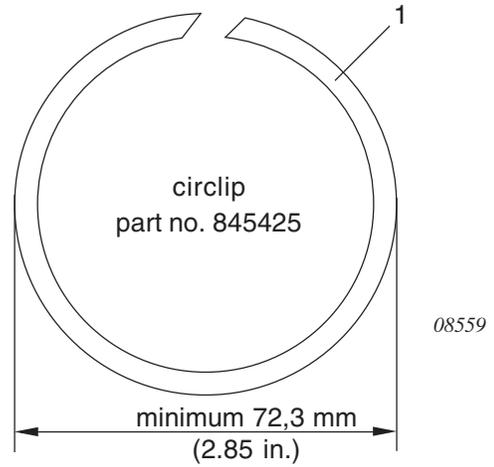
Fig. 1

The measurement of the circlip takes place in developed condition!

On repair work on sprag clutch (2) or at engine overhaul the circlip 68 part no. 845420 has to be replaced by the circlip 70 (1) part no. 845425. Verify by inspection if the new circlip 70 is already fitted. See fig. 1

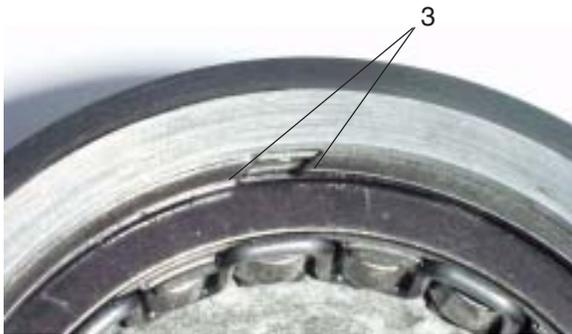
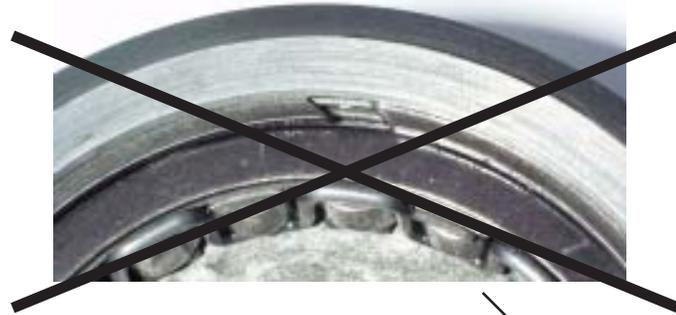
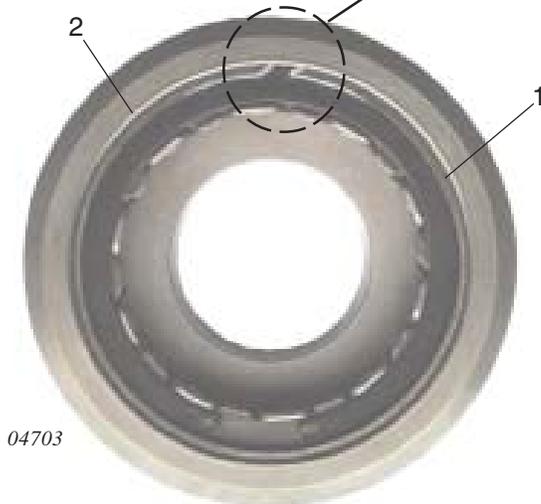
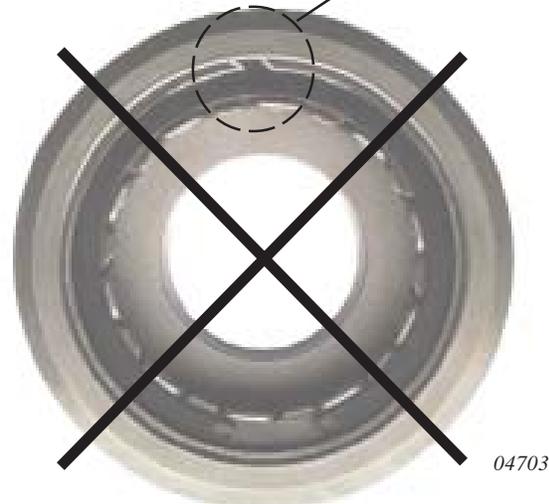
Fig. 2

DETAIL A: shows the correct position of the circlip

DETAIL B: shows the incorrect position of the circlip

■ **CAUTION:** Make sure that the new circlip will be fitted as depicted in fig. 2 Detail A. To warrant a tight fit pay attention to correct position of the circlip ends (3).
