SERVICE LETTER

NON-APPROVED MODIFICATIONS OR USE OF ROTAX® UNAPPROVED ENGINE COMPONENTS OR ACCESSORIES FOR ROTAX® AIRCRAFT ENGINES

SL-912 i-005 R1

3.1.1) Example of a “repaired” crankshaft

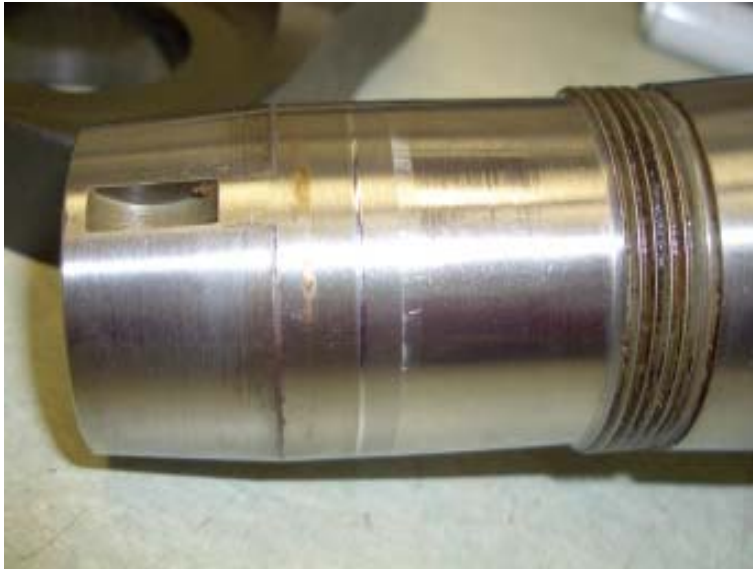
fig. 1

- The crankshaft has a ROTAX[®] part no. 888164 and a serial number (S/N) of S/N 11798, but was not marked as overhauled and shows some serious deficiencies:
 - signs of corrosion in the area of the oil seal (see fig. 1)
 - crankshaft was beyond the out of round limit
 - torque at twist test was below limit
 - a conrod bearing shows signs of wear (see fig. 2)
 - contamination in the oil channels (see fig. 3)

Such a crankshaft is not airworthy and should not be installed or any parts reused according to ROTAX[®]-instructions.

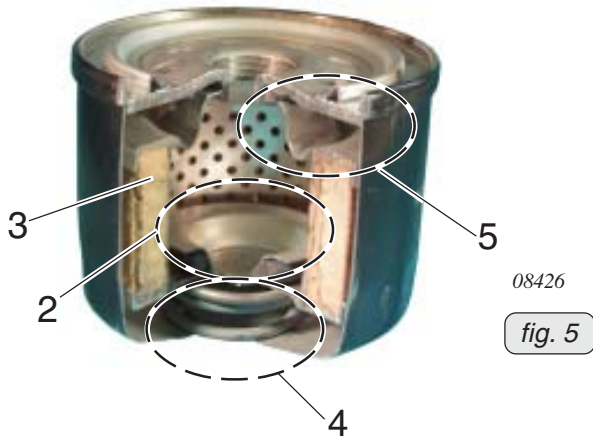
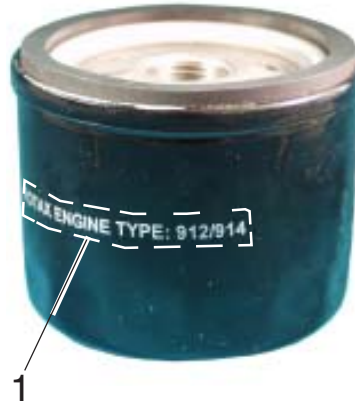
non-genuine ROTAX® oil filter

- The oil filter infringes on copyright/without permission ROTAX[®] a ROTAX ENGINE Type 912/914 label (1) and has some serious technical deficiencies:
 - no by-pass valve (2) = in case of contamination this can lead to a completely blocked oil system
 - filter insert (3): shorter than the genuine = less filter surface and reduced dirt pick-up
 - no genuine ROTAX[®] part number
 - sharp-edged inner spring (4) = this can cause wear and cracks in the filter housing
 - no return-valve (5) = after switching-off the engine self-draining of the oil filter will not be avoided. When the engine is started again it will require a longer time (less film lubrication) until the necessary operating pressure is reached.

- 1 label
- 2 by-pass valve
- 3 filter insert
- 4 spring
- 5 no return valve installed

Such an oil filter is not airworthy and should not be installed or be further used according to ROTAX[®]-instructions.

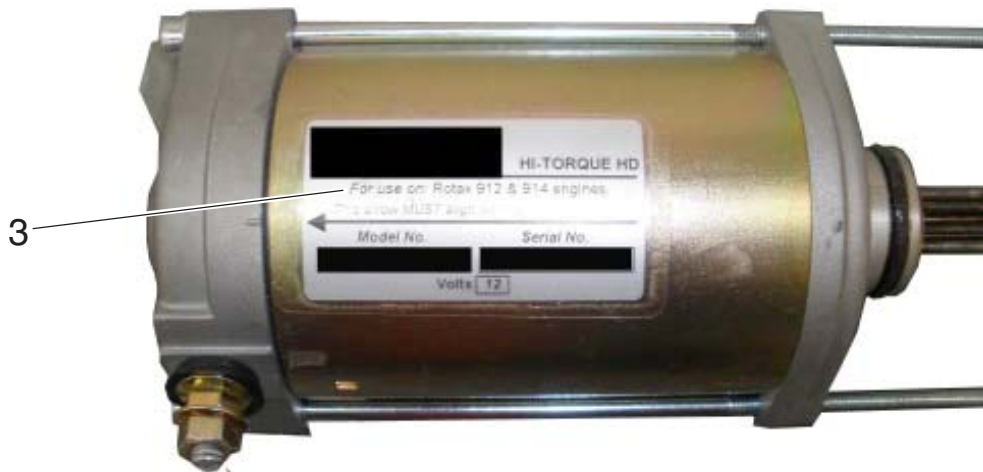
fig. 7

- The electric starter uses a ROTAX[®] 912/914 engine label (1) without permission from ROTAX[®] and has some serious technical deficiencies:
 - no oil seal (1) in support (2)
 - ▲WARNING: This can cause oil return issues into the oil tank due to loss of crankcase pressure.
 - no genuine ROTAX[®] part number (4)
 - no standard serial number (4), which is signed on essential components for traceability at ROTAX[®]

- 1 oil seal
- 2 support
- 3 label
- 4 ROTAX® part number and serial number

Such an electric starter is not airworthy and should not be installed or be further used according to ROTAX[®]-instructions.

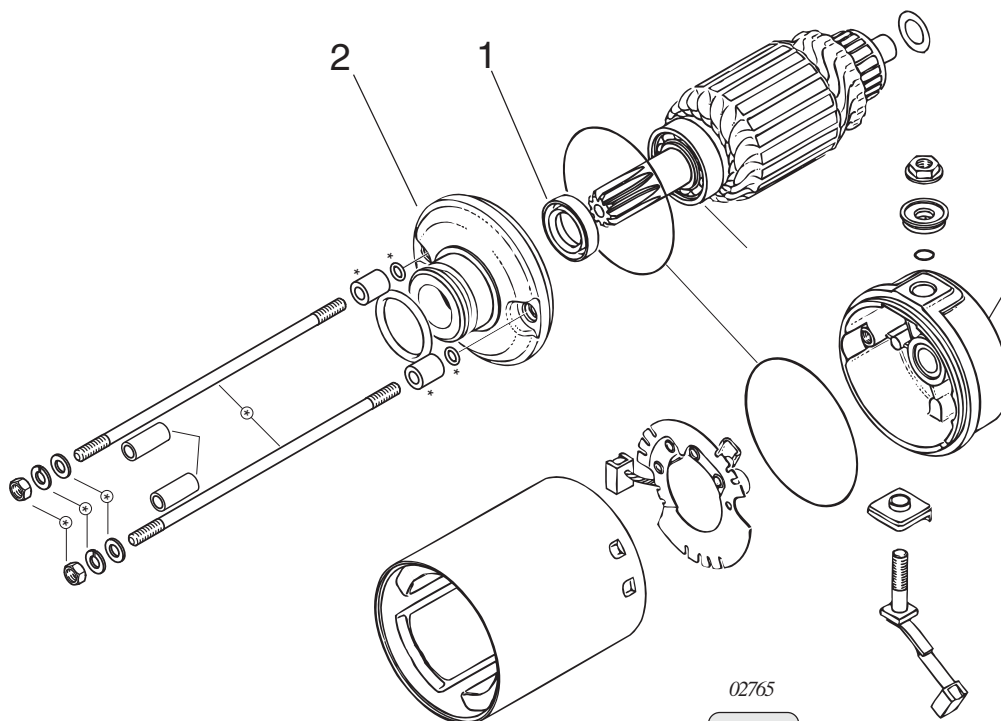
fig. 9

genuine ROTAX® electric starter
