**ROTAX engine type 505 and type 505 A**

- Object:** Introduction of a new electronic box with a modified wiring on the stator plate.
- Concerned:** Motorglider engines type 505 and 505 A up to engine serial no. 3.332,887 in case of replacement, beginning with engine serial no. 3.332,888 the new electronic box is mounted in general.

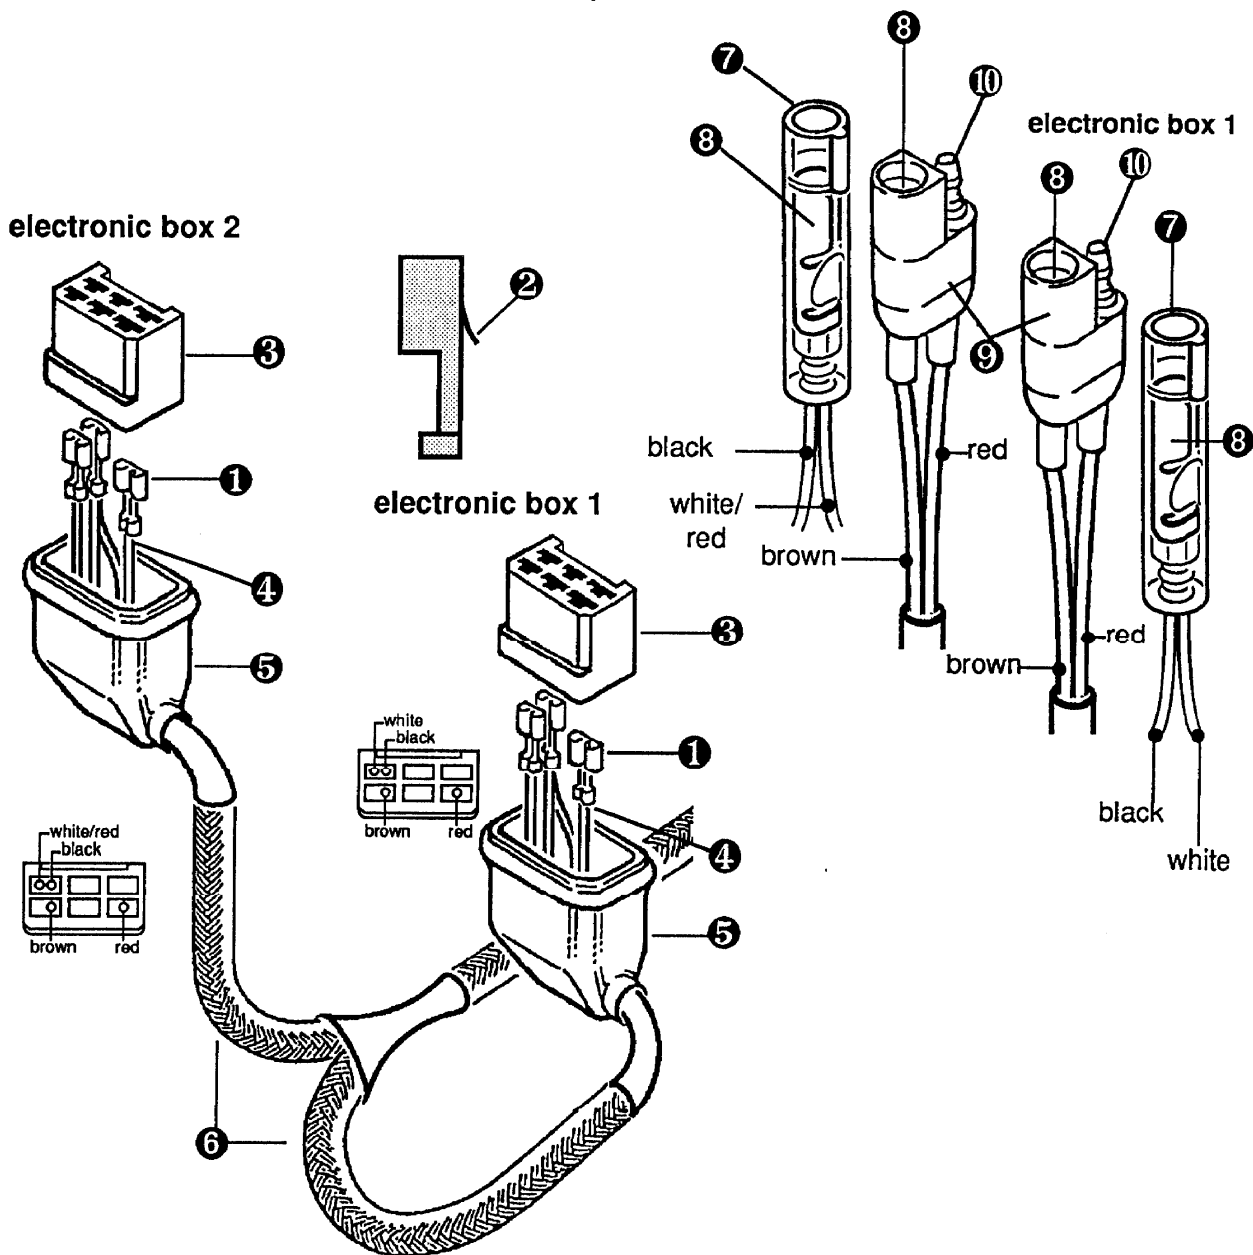
- 4.1) Dismount all faston connectors ①, by depressing the barb ②, from the connector housing ③.
- 4.2) Cut the cables at the end ④ of the faston connectors.

- 4.3) Remove protection caps ⑤.
- 4.4) The screening metal braid ⑥ is no more necessary, however it should remain on the harness as the mass cables for the ignition boxes are soldered on the screening metal braid.
Otherwise, you have to install two new mass cables, beginning at the stator plate.

- 4.5) On the harness for the sparking circuit 2 the shrink hose has to be cut off and the brown mass cable (70 mm, included in the retrofit kit) has to be soldered instead of the mass cable, which is too short. The new shrink hose (included in the retrofit kit) has to be fitted.

- 4.6) Put the new insulation sheath over the black and white wires of sparking circuit 1 and fit the faston connector on both wires. The wires with the fitted faston connector have to be fitted in the insulation sheath till it is locked. The same happens with the black and the white/red wires of sparking circuit 2.

- 4.7) Put the connector housing ⑨ on the red and brown wires of sparking circuit 1 resp. 2. Fit the faston connector ⑩ on the red conduction and the faston connector ⑧ on the brown one.

ATTENTION: Do not exchange the colours of the wires!

- 4.8) Mount the DUCATI-electronic boxes by suitable holding devices (have to be requested from the aircraft manufacturer) and establish the connection according to the wiring diagram (in the operator's manual).
