**Safety - check of the BING - carburetors used in all
ROTAX UL - engines****1) General information:**

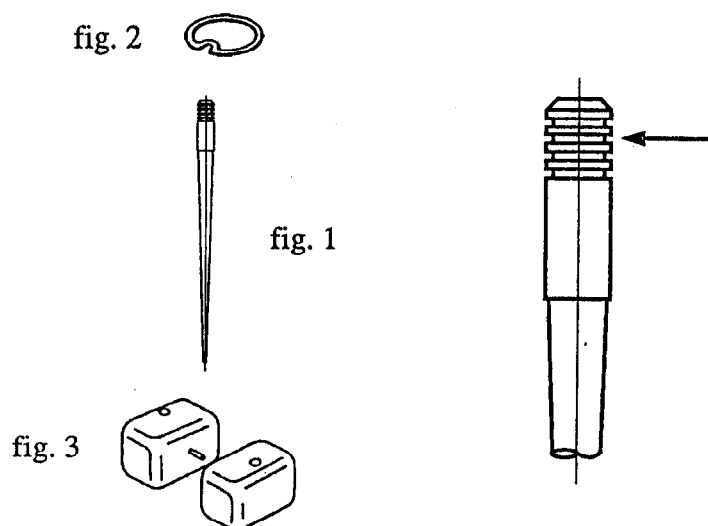
Premature wear on carburetor-parts e.g. jet needle, needle clip and float can cause engine troubles, engine stoppage or emergency landing.

Critical are those cases, where the jet needle rotates because of vibrations, caused by a loose fit of the needle clip.

2.1) Check **jet needle** (fig. 1) and **needle clip** (fig. 2) for wear. If you can detect any wear in the ring groove of the jet needle (see arrow) renew both parts immediately.

2.2) **Float** (fig. 3): Formerly the float had a aluminium-tube-guide which was flanged on both ends. If the material of the floats is broken at the guide tube or if guide is worn, exchange both floats. Carb jets might be blocked.

The aluminium-tube-guide was replaced by a not flanged brass-guide with better sliding-quality. Make the check on floats with brass-guide too.

Carry out check according to item 2 every 50 hours of operation. (See Maintenance plan SI 3 UL 91 - E)
